LightSail 2 Image-Based Engineering Assessment

LightSail 2 Mission Operations Team

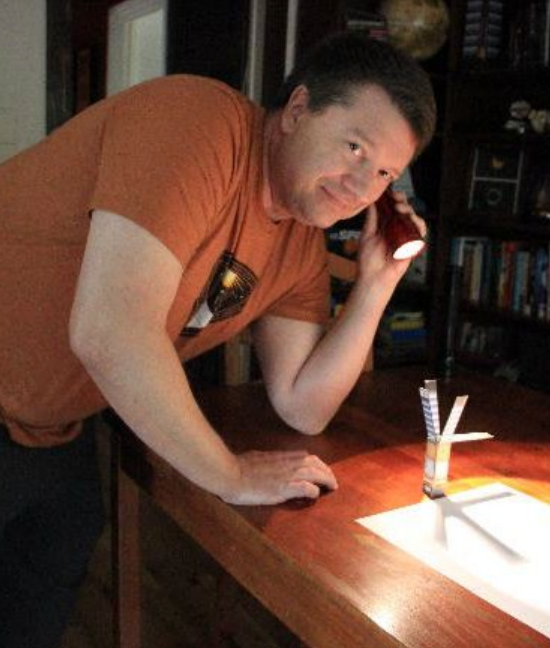
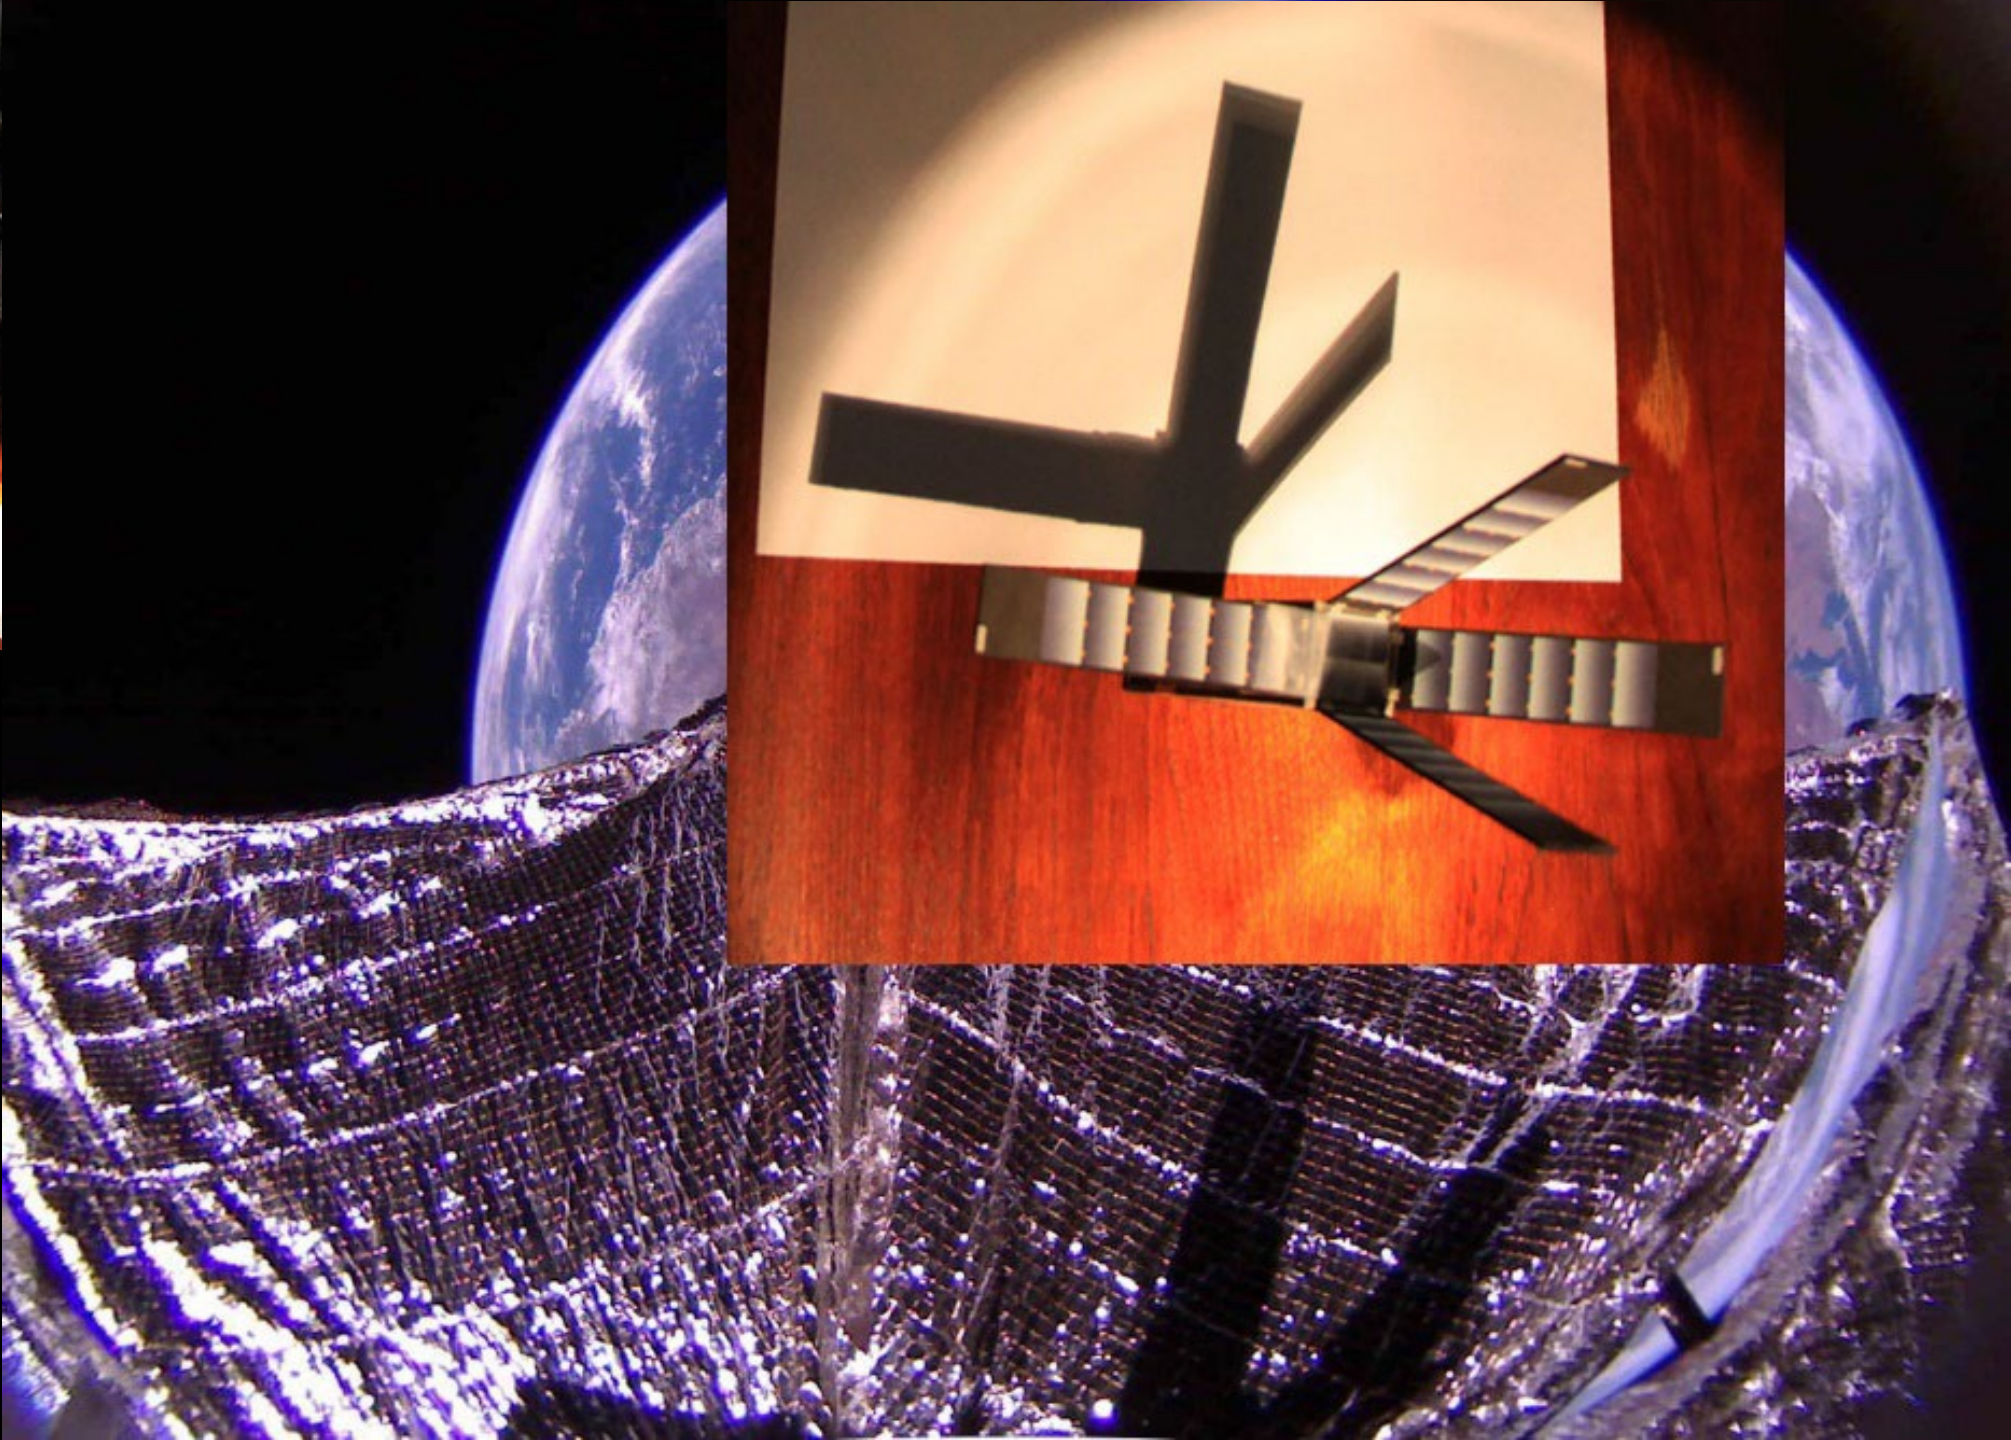
Anomalies detected through imaging included the incomplete deployment of a solar panel, which was then compensated for...

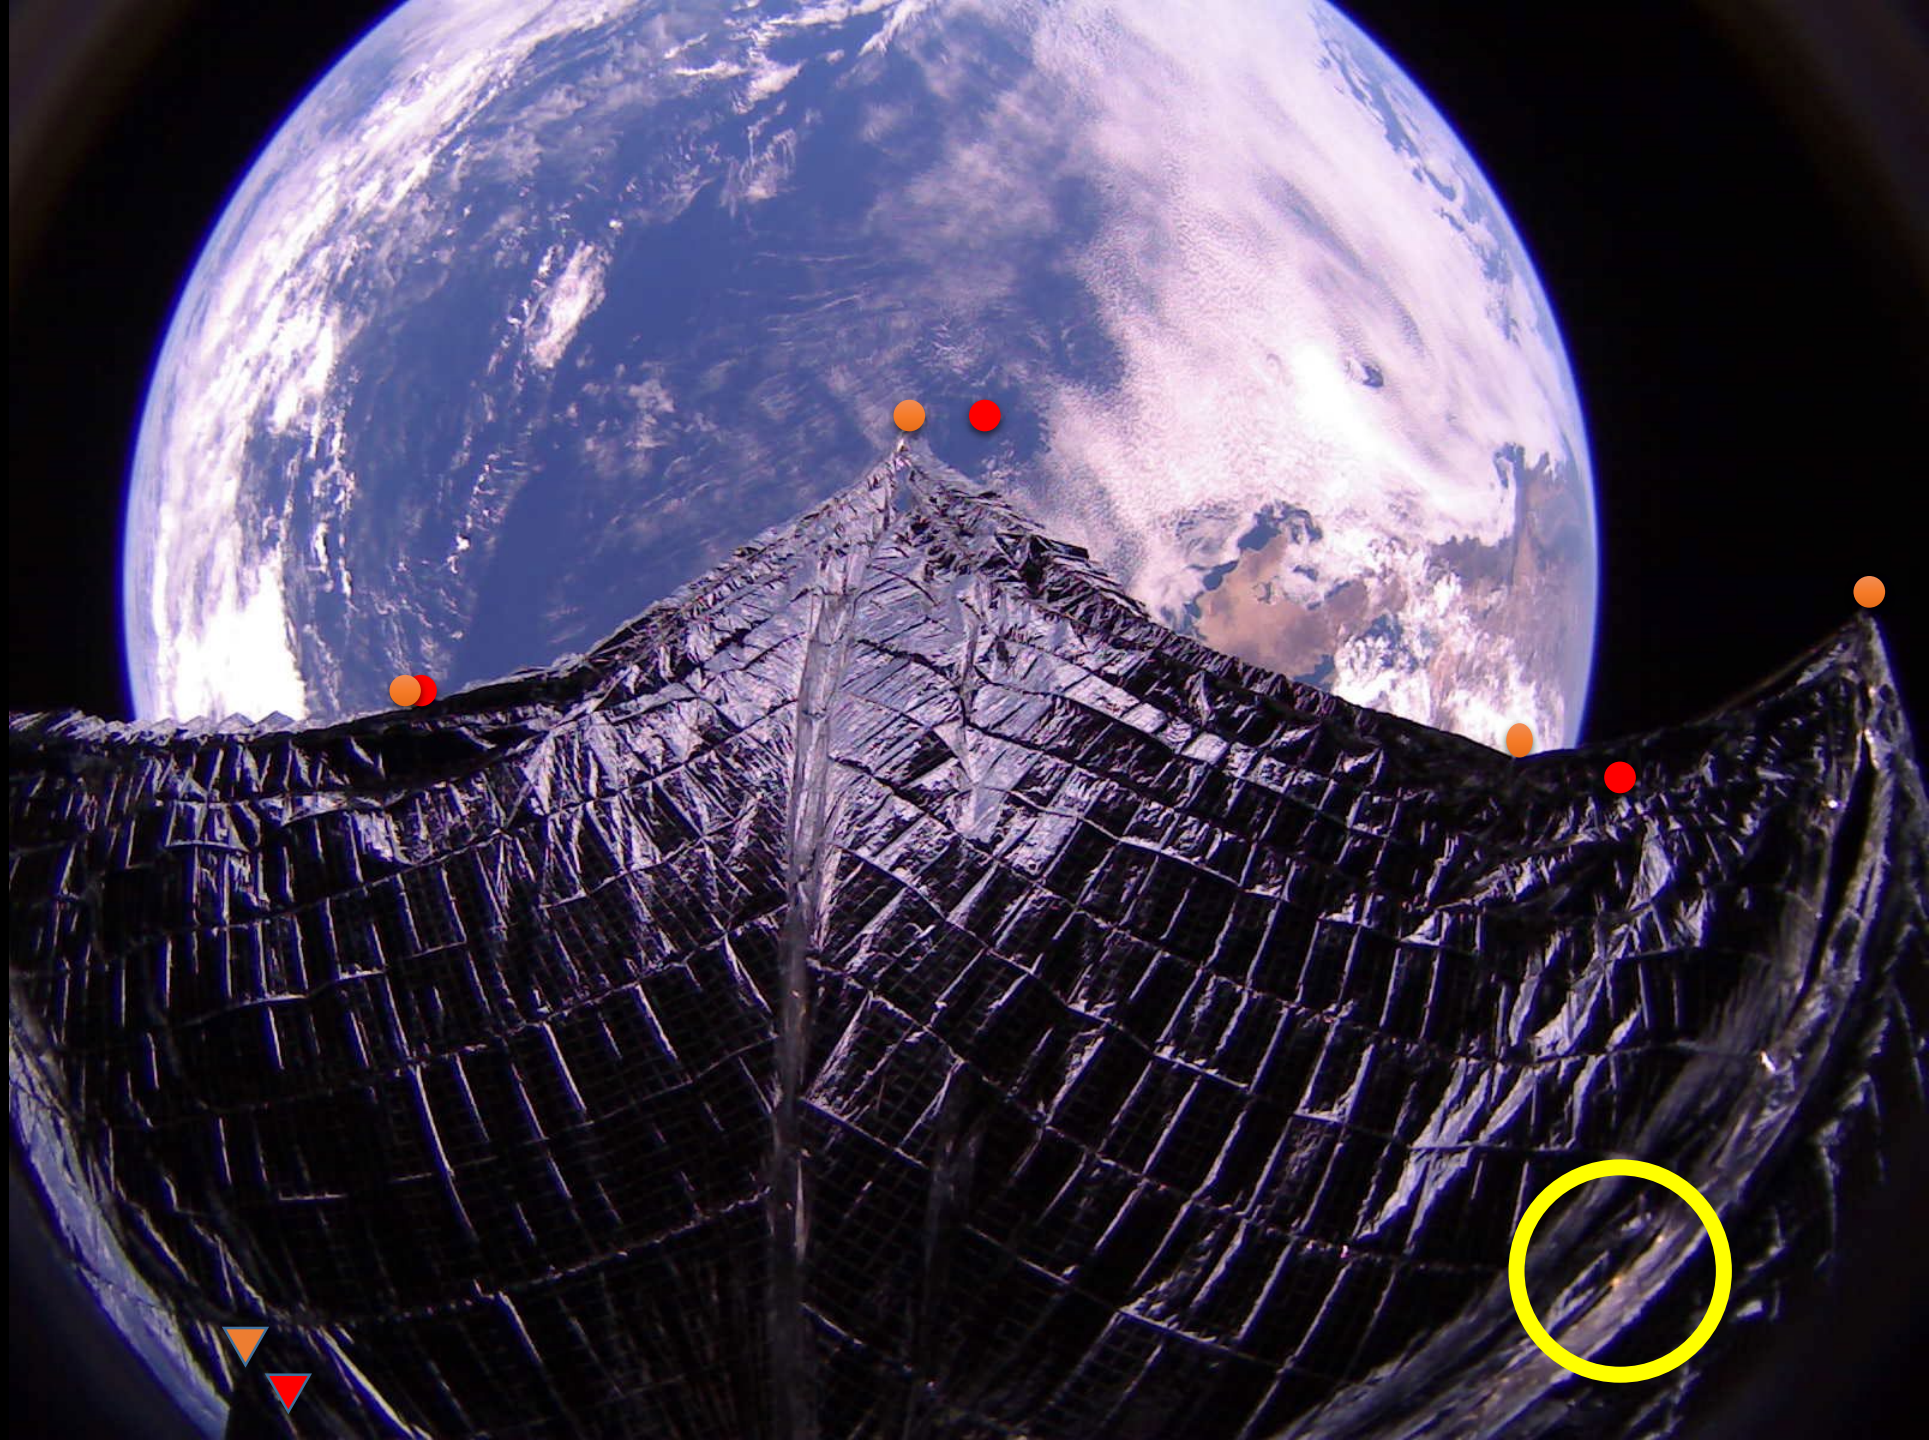
08/29/19
D+37

No boom
change.
Gap
opening.
Significant
+Y panel
movement

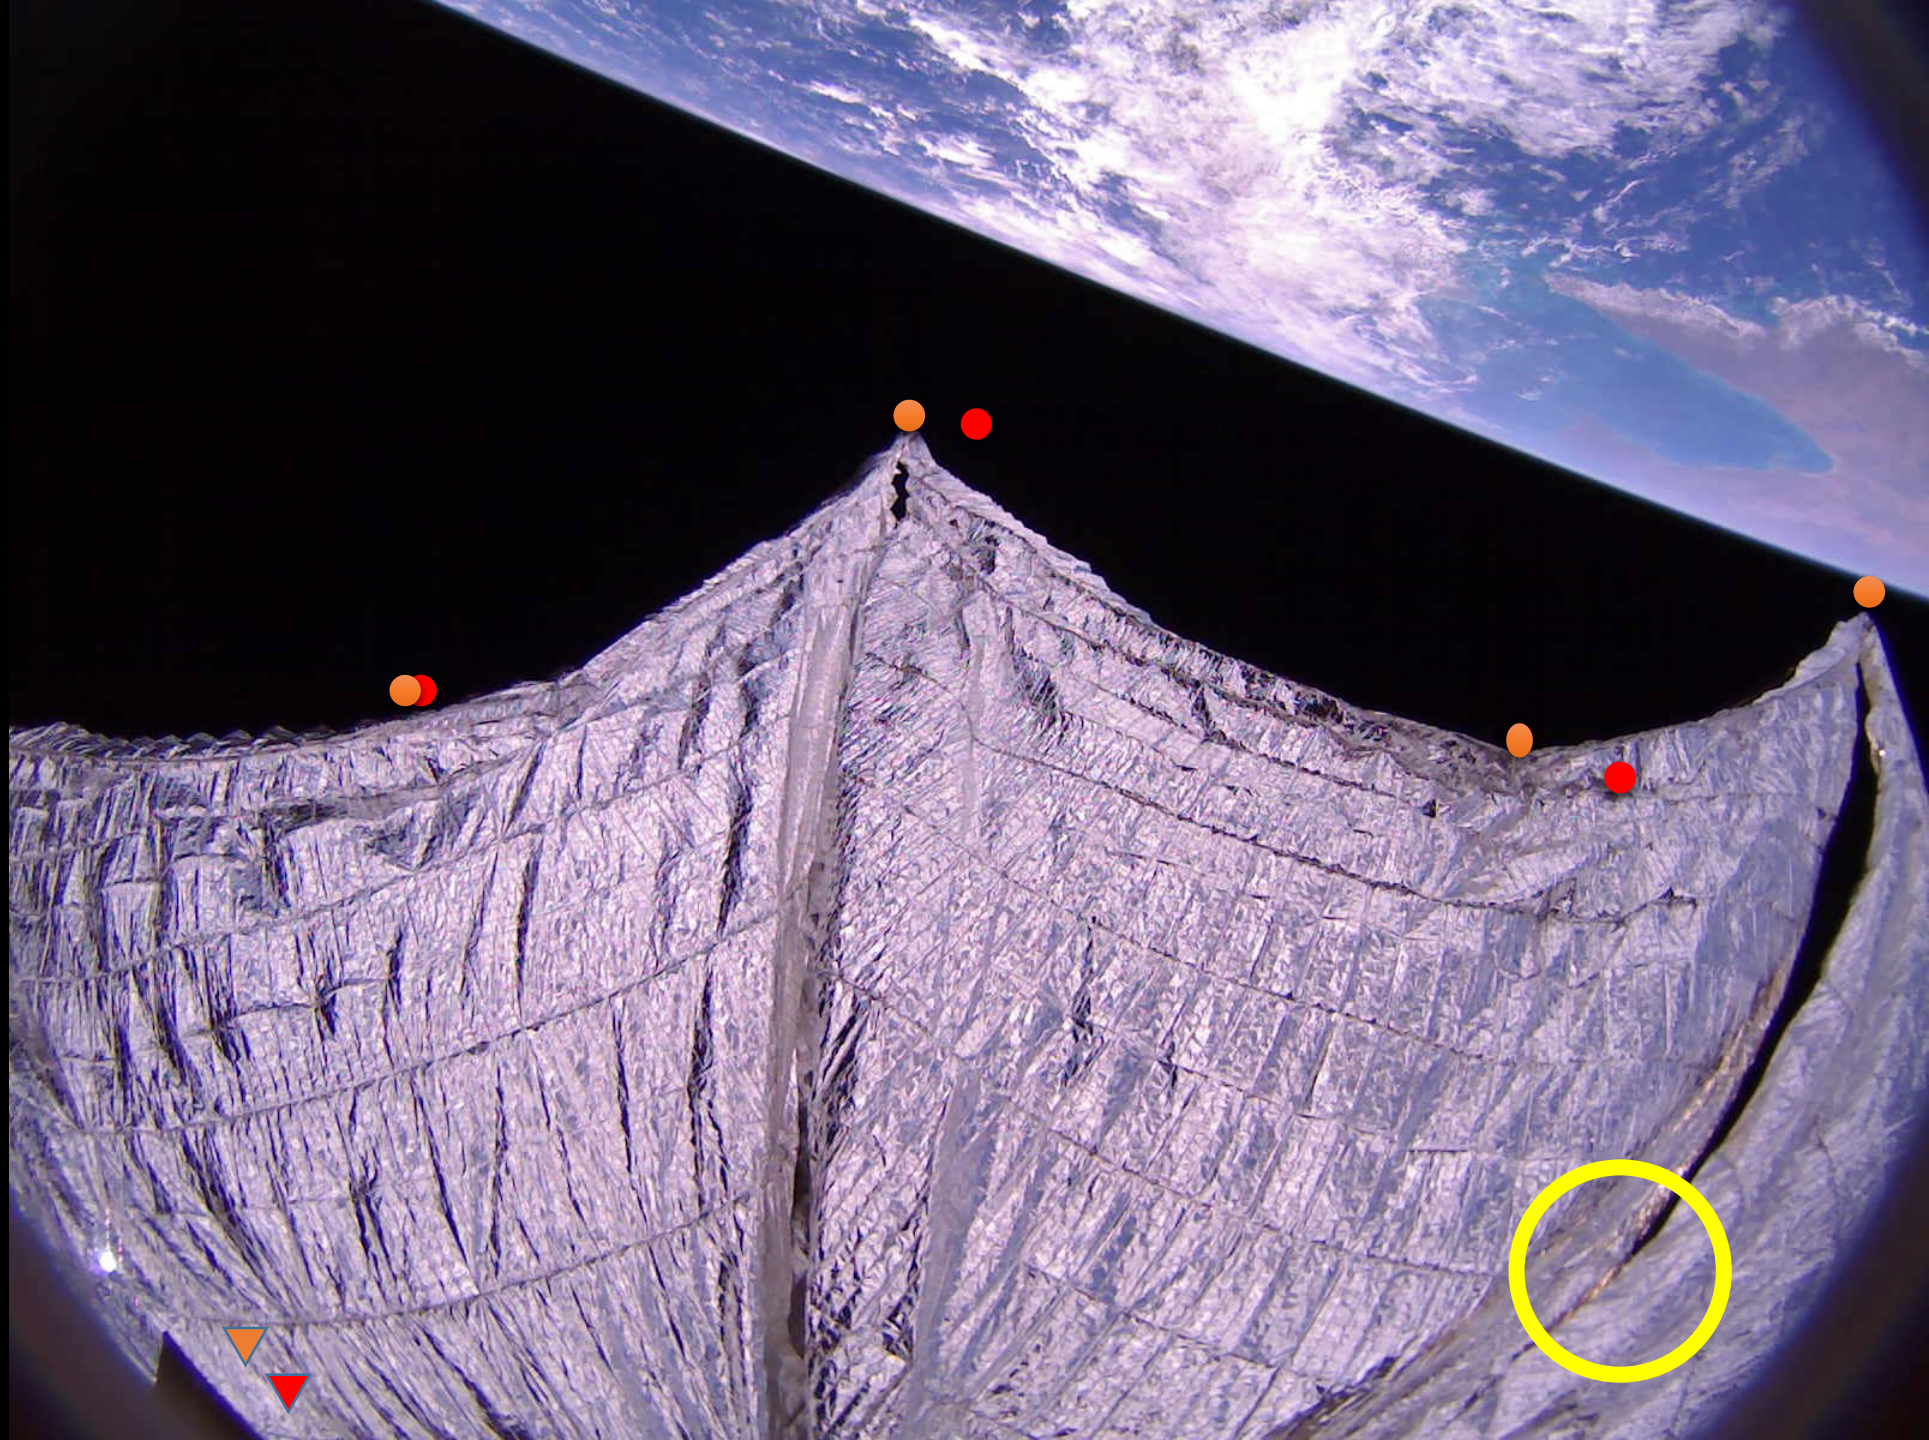
09/02/19
D+41
Gap
opening.
Note
orthogon
al boom
segment
parallel to
yellow
line.

- In the previous image (9/2 D+41) we see the now very obvious linear feature parallel to the sail edge connecting to the boom tip. This is the last image in which it appears.

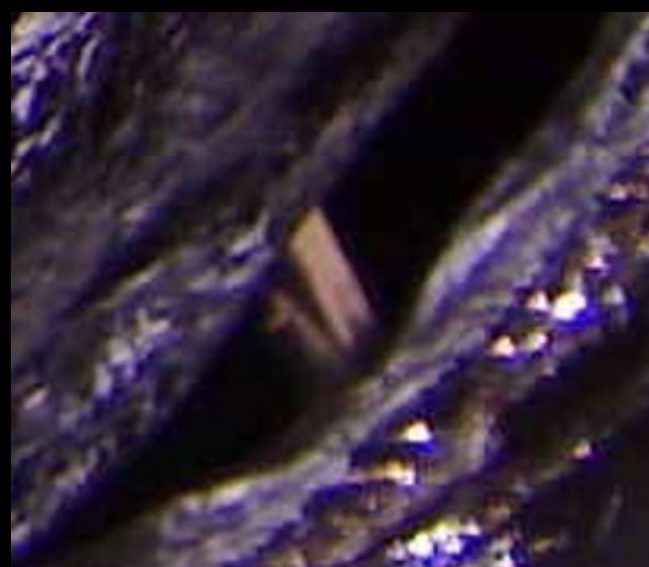
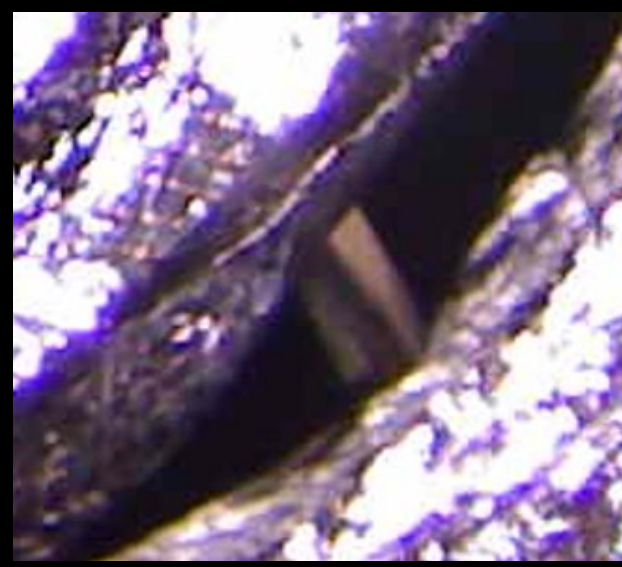
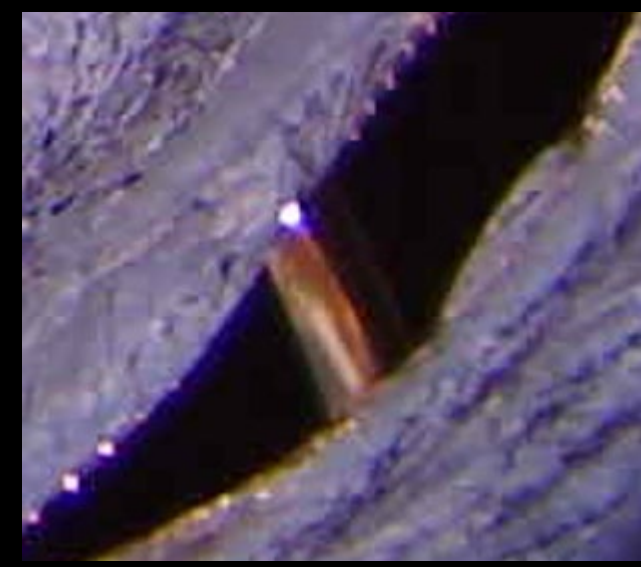
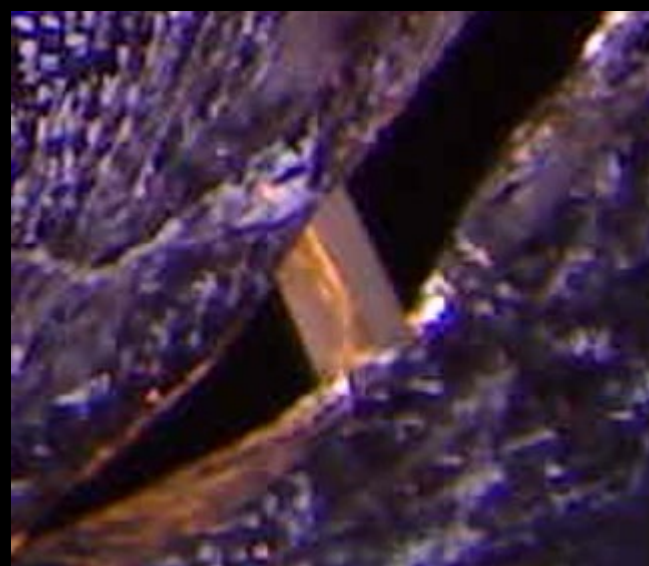
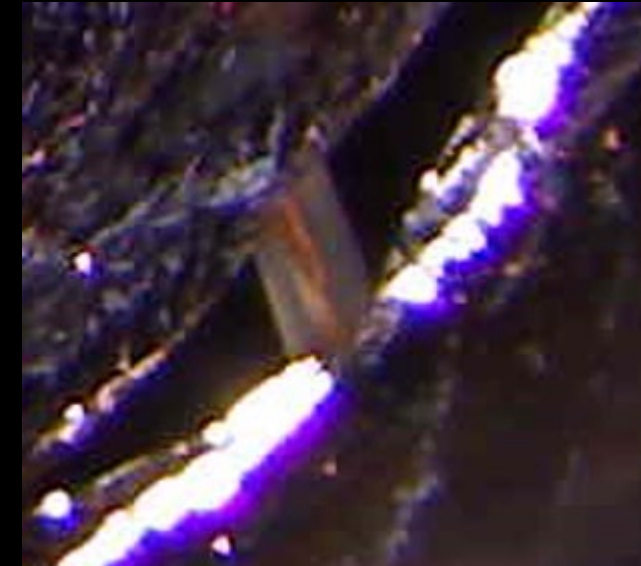
The “buckle” throughout the mission: interpretation – boom is bent not split?

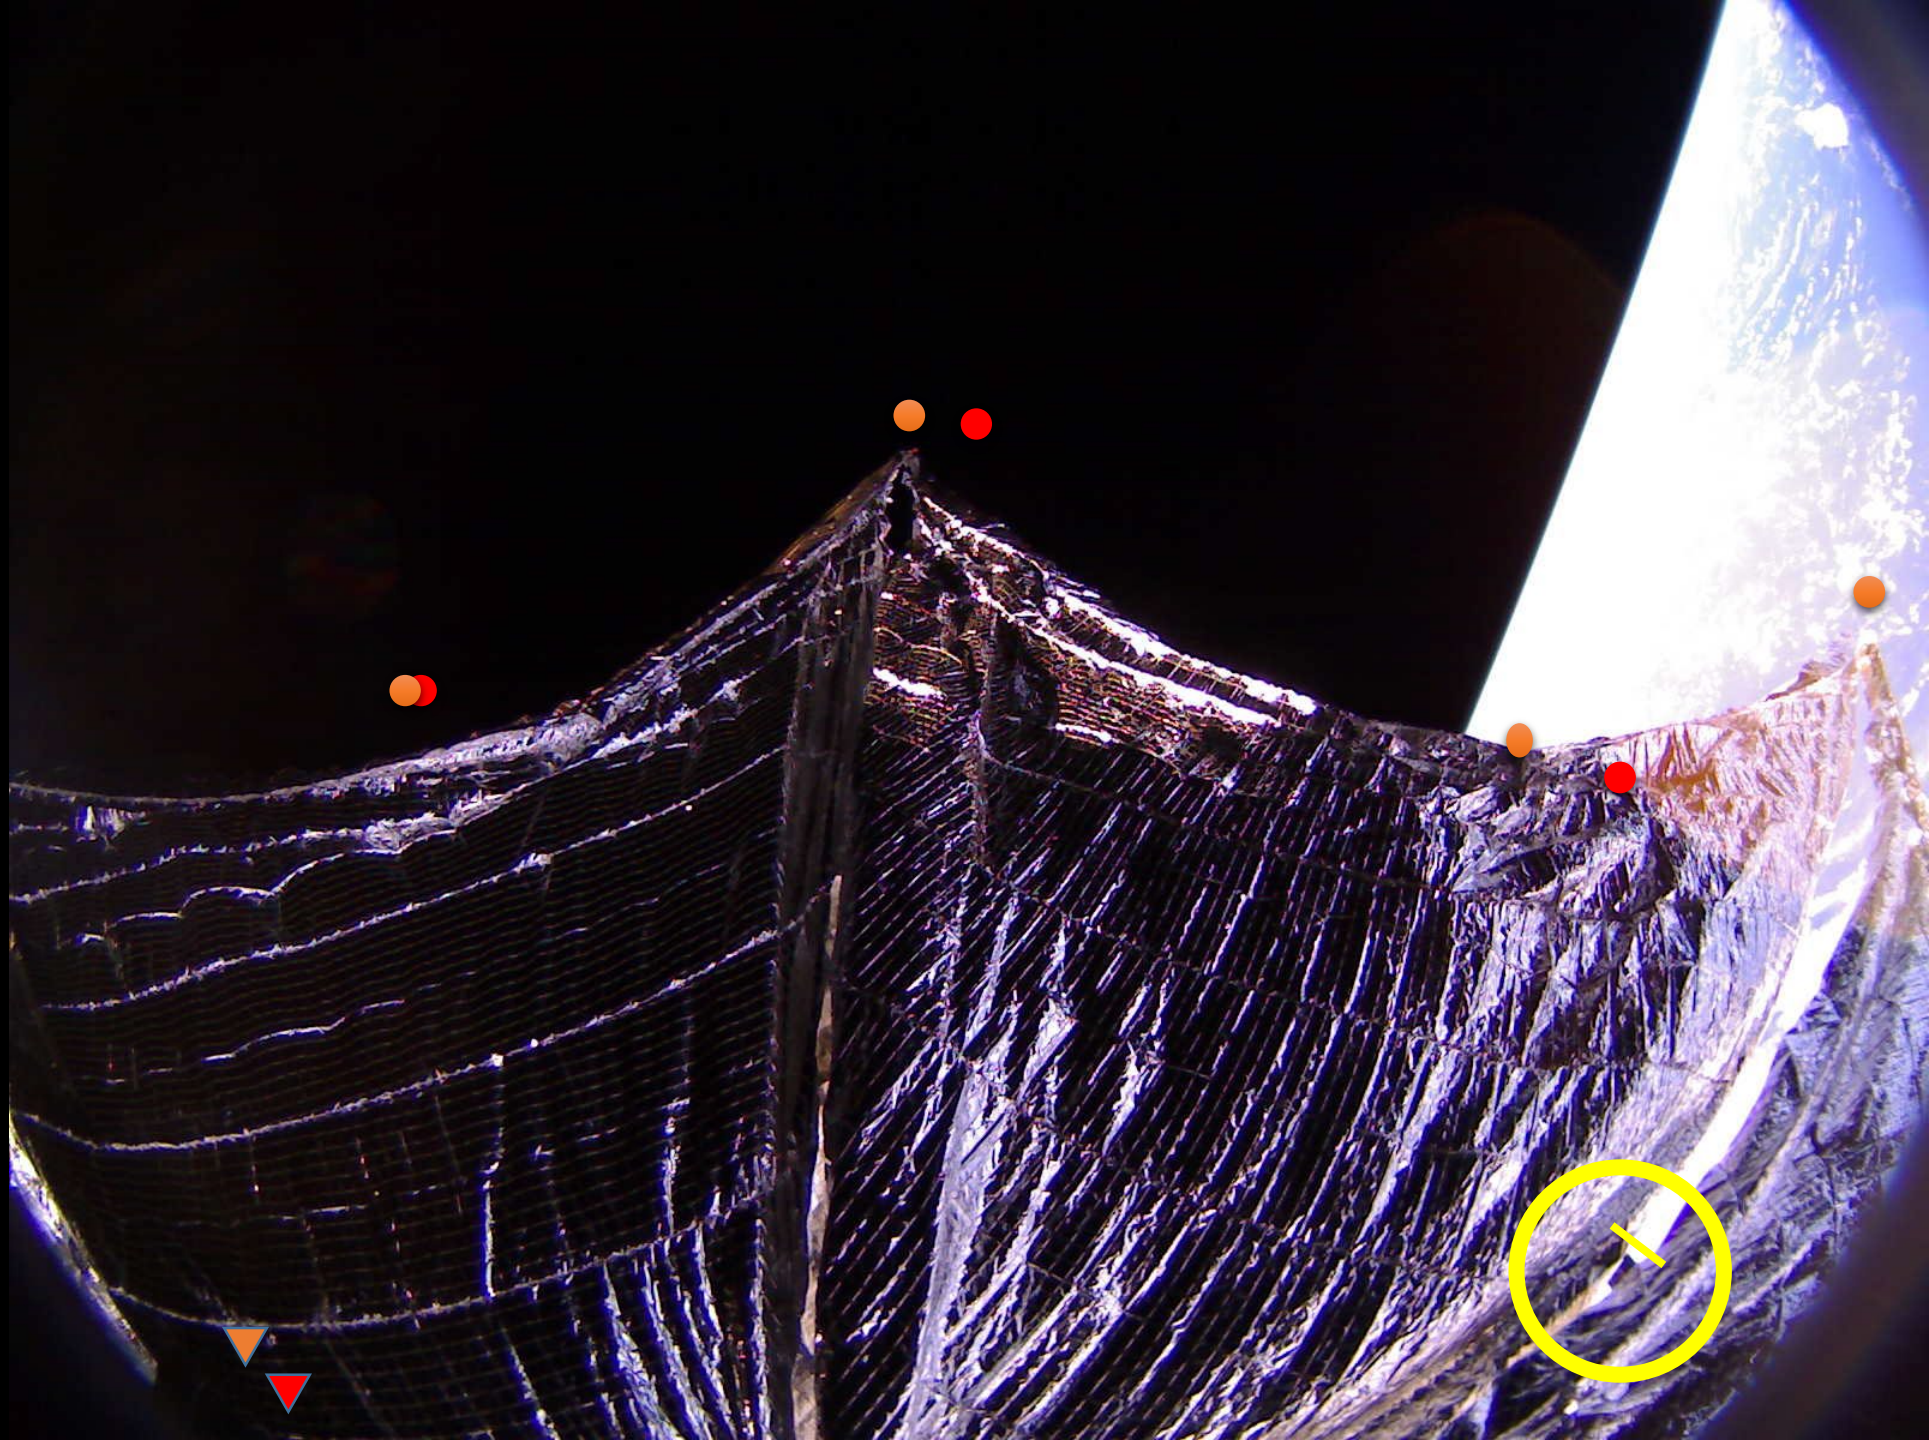
09/28/19
D+67.
Orange
dots are
still 7/31.
Orthogon
al boom
segment
below
yellow
line.
New
yellow
dots for
future
comparis
ons.

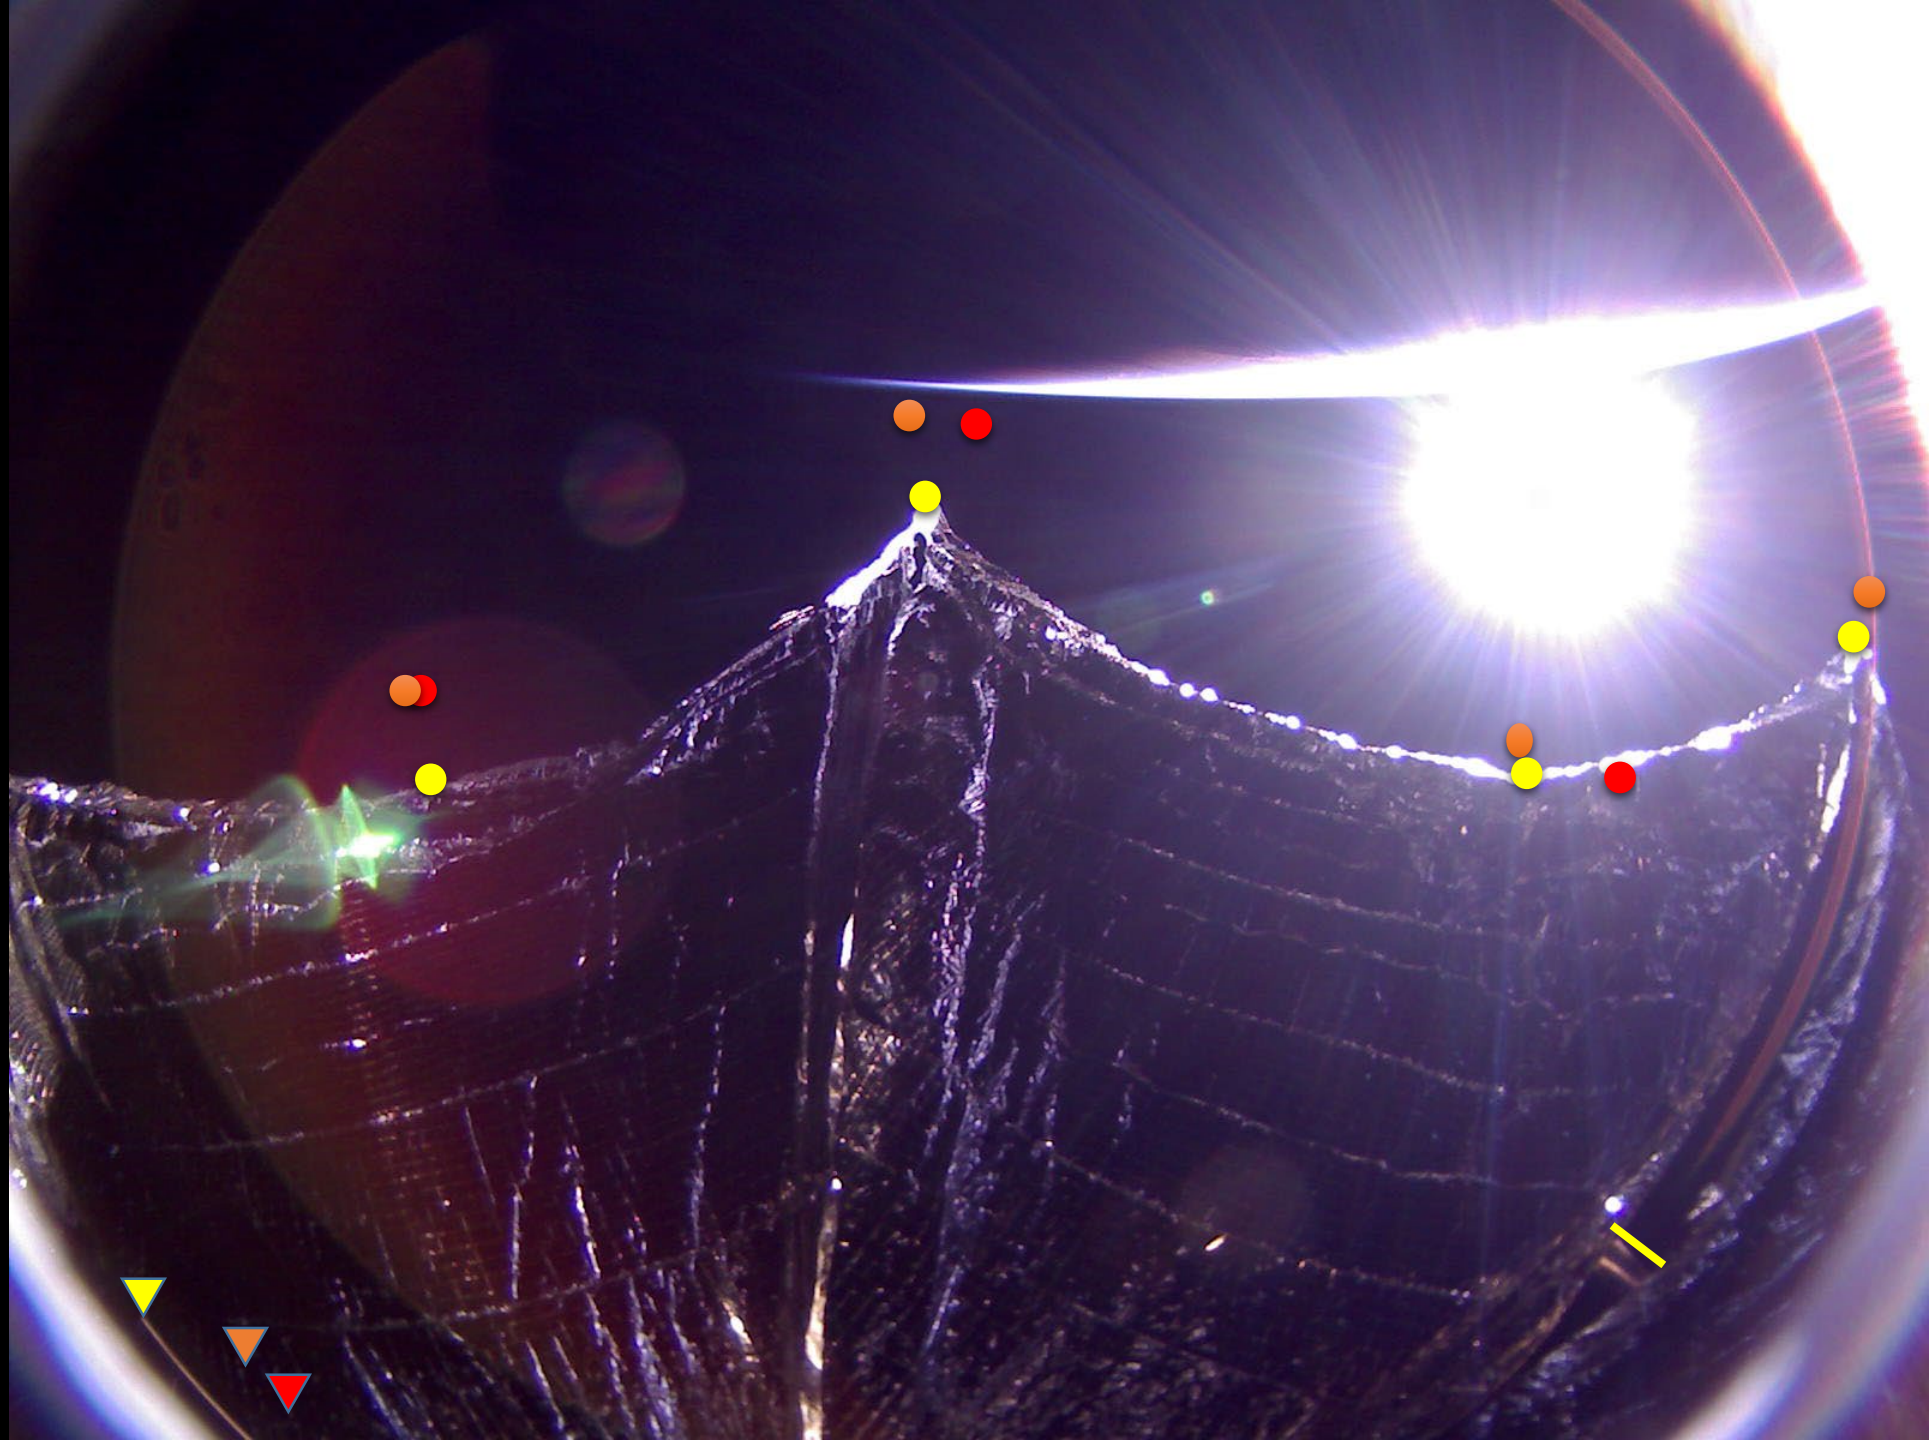
Buckled Boom Anomaly: Visible from Camera 2, one of the 4 spacecraft booms (-Y) buckled, seemingly in a Z-fold pattern, becoming worse over the first 125 days after deployment, then changing very little after that.

11/25/19
D+125
Yellow
dots are
still 9/28.
New
green
dots for
future
comparis
ons.

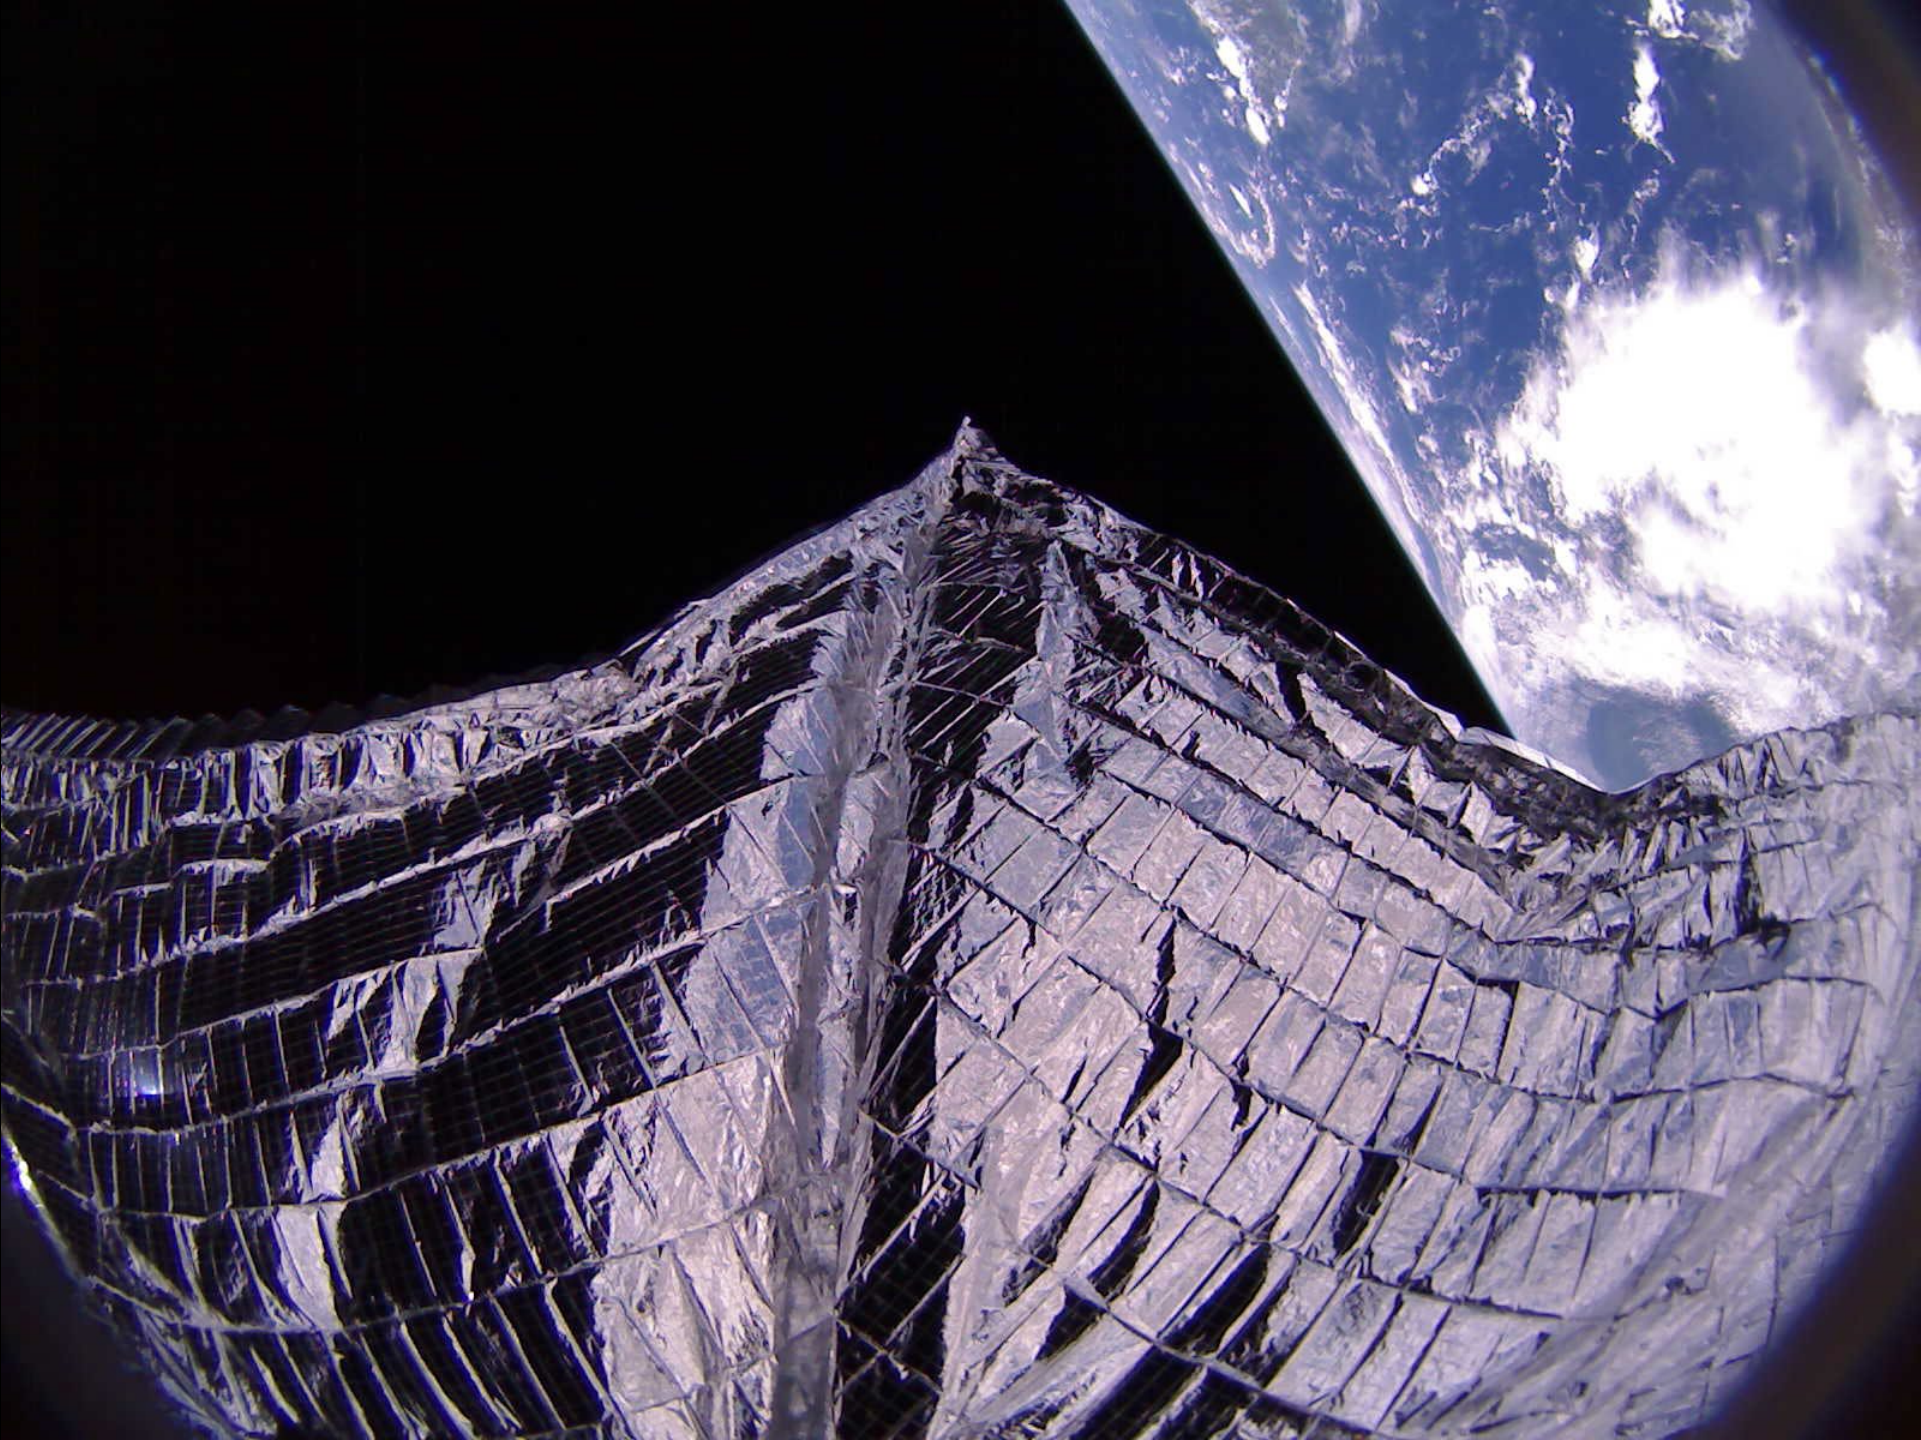
Crinkles appeared and got worse in the first weeks of the mission.

Shown here is a C2 image just after deployment.

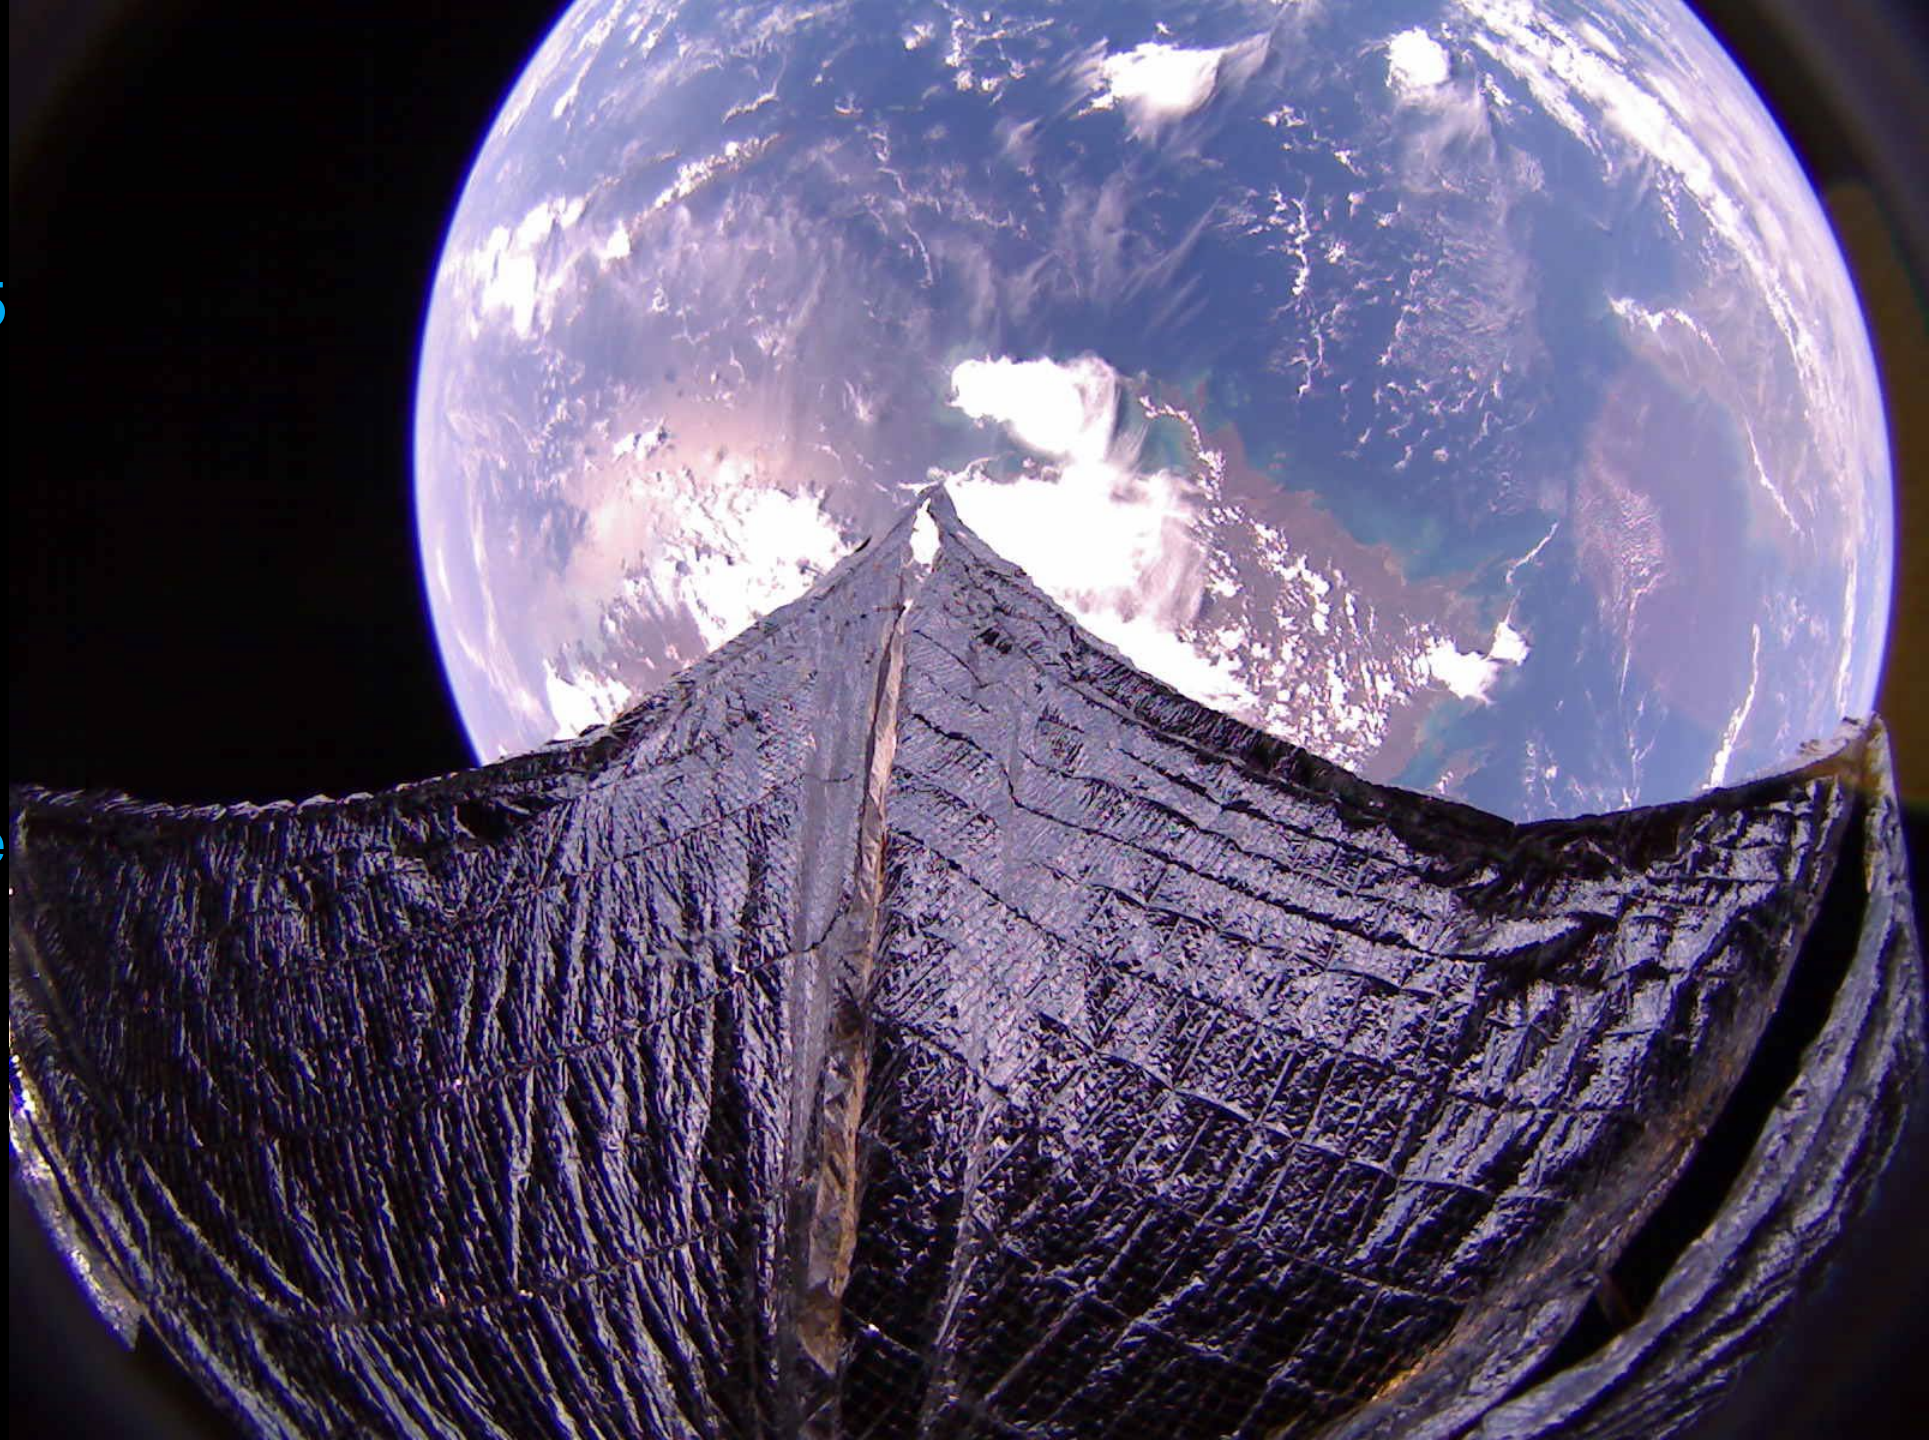
Shown here is a C2 image on D+125 11/25/19.

Compared to the last image notice the crinkles.
