LightSail 2 Image-Based Engineering Assessment

LightSail 2 Mission Operations Team

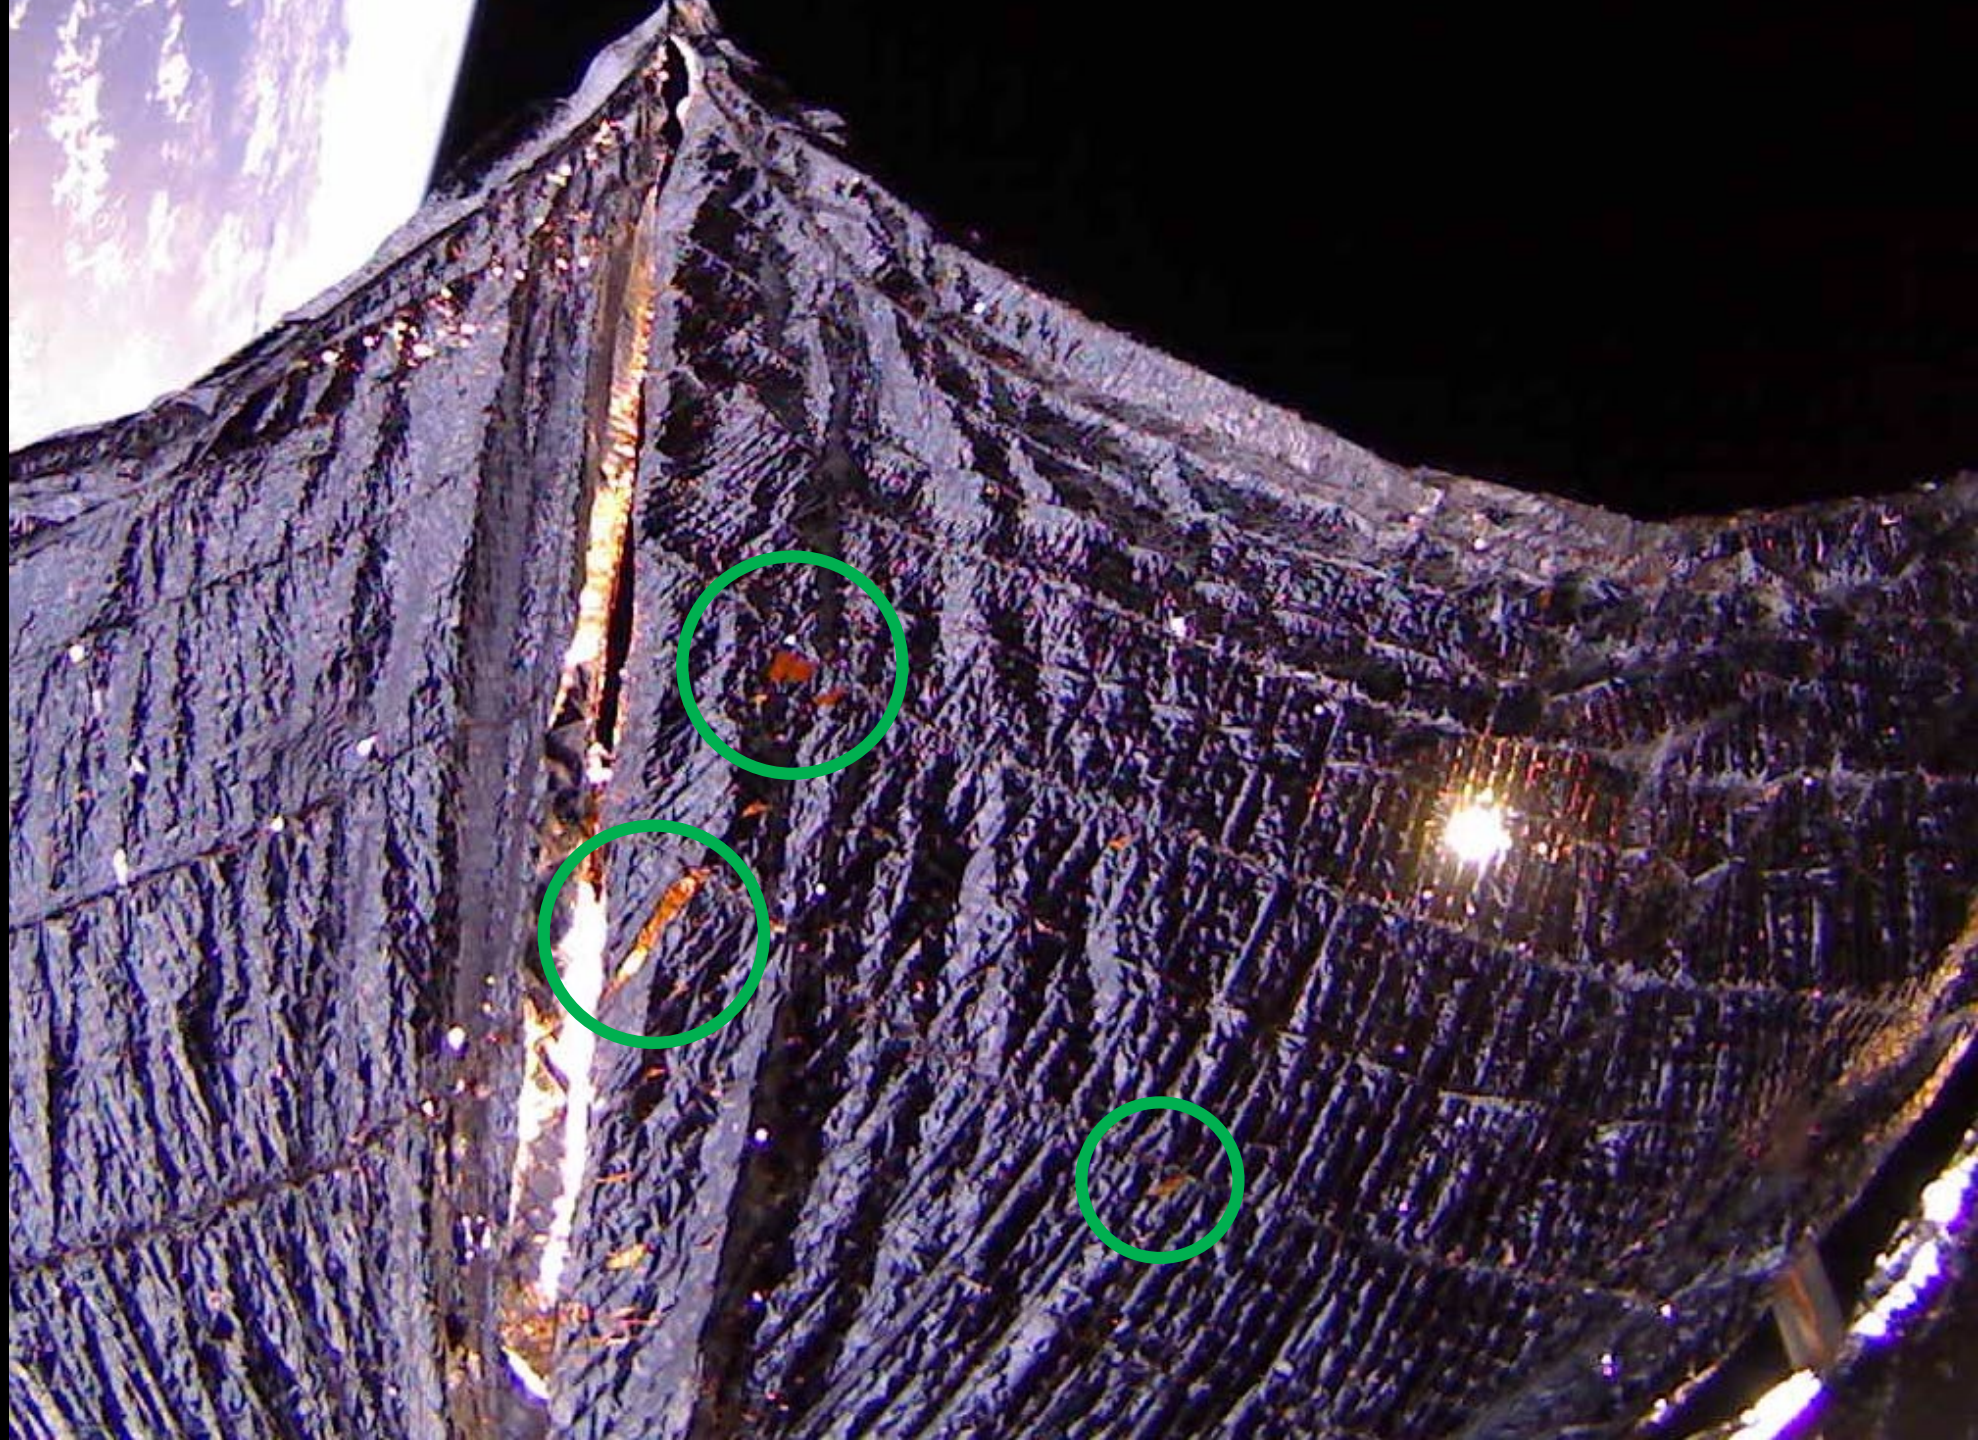
As shown in this C2 D+525 1/8/21 image, small areas, particularly on the camera 2 side, appear orange and to let light through more when lit from behind. They often appear darker than the surroundings when back lit. They appeared, most clearly months into the mission..

Several sail degradation processes were observed, likely mostly caused by atomic oxygen at the approximately 700 km altitude of most of the mission.

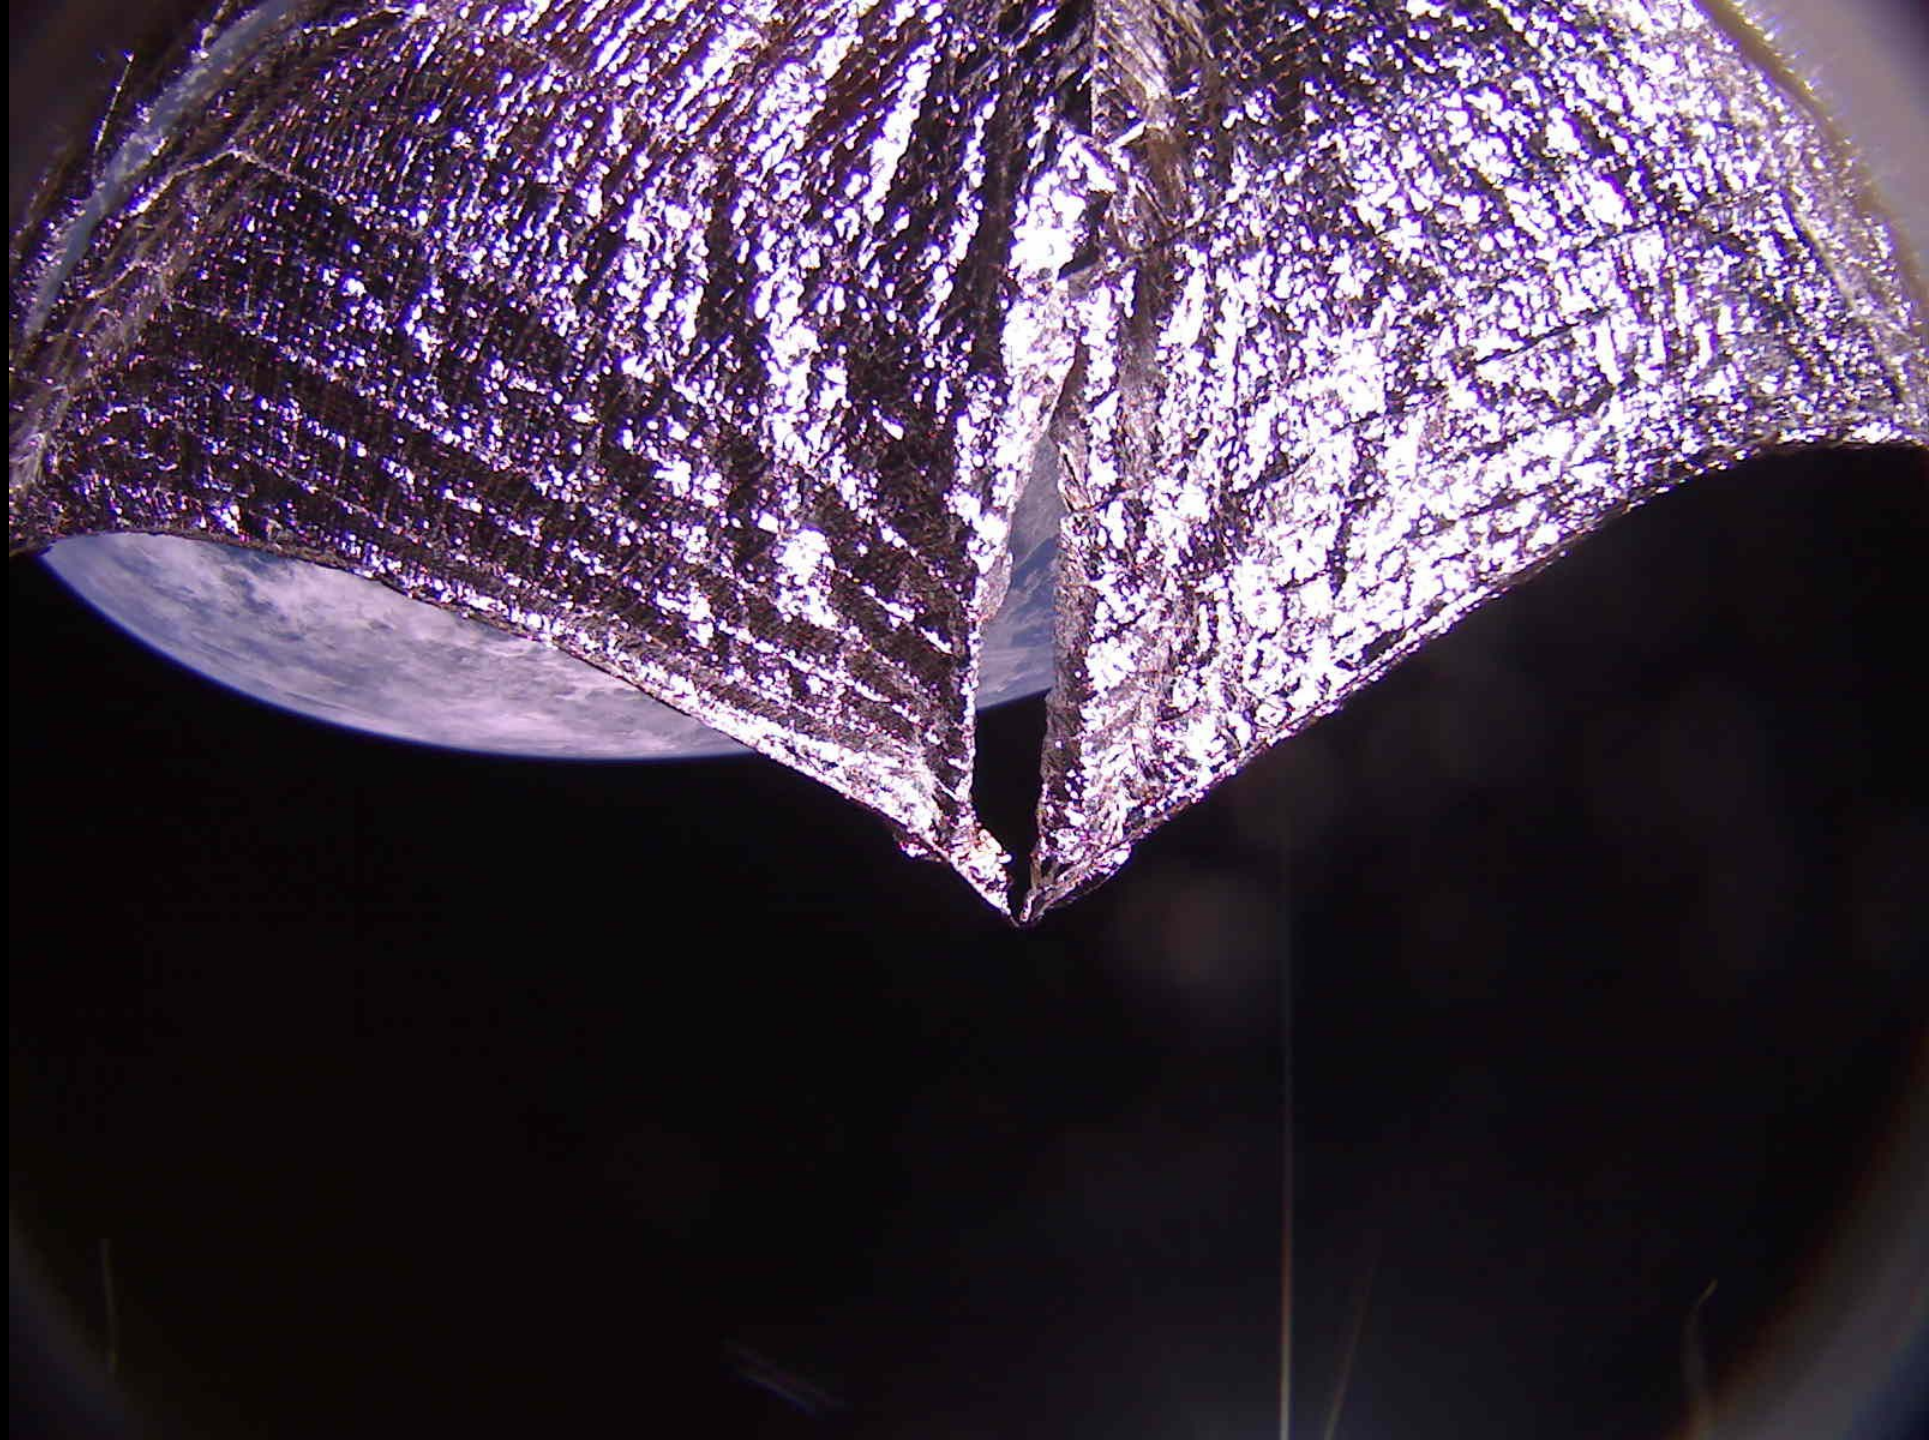
LS2
Camera 1
12/10/20
OITL
Spots

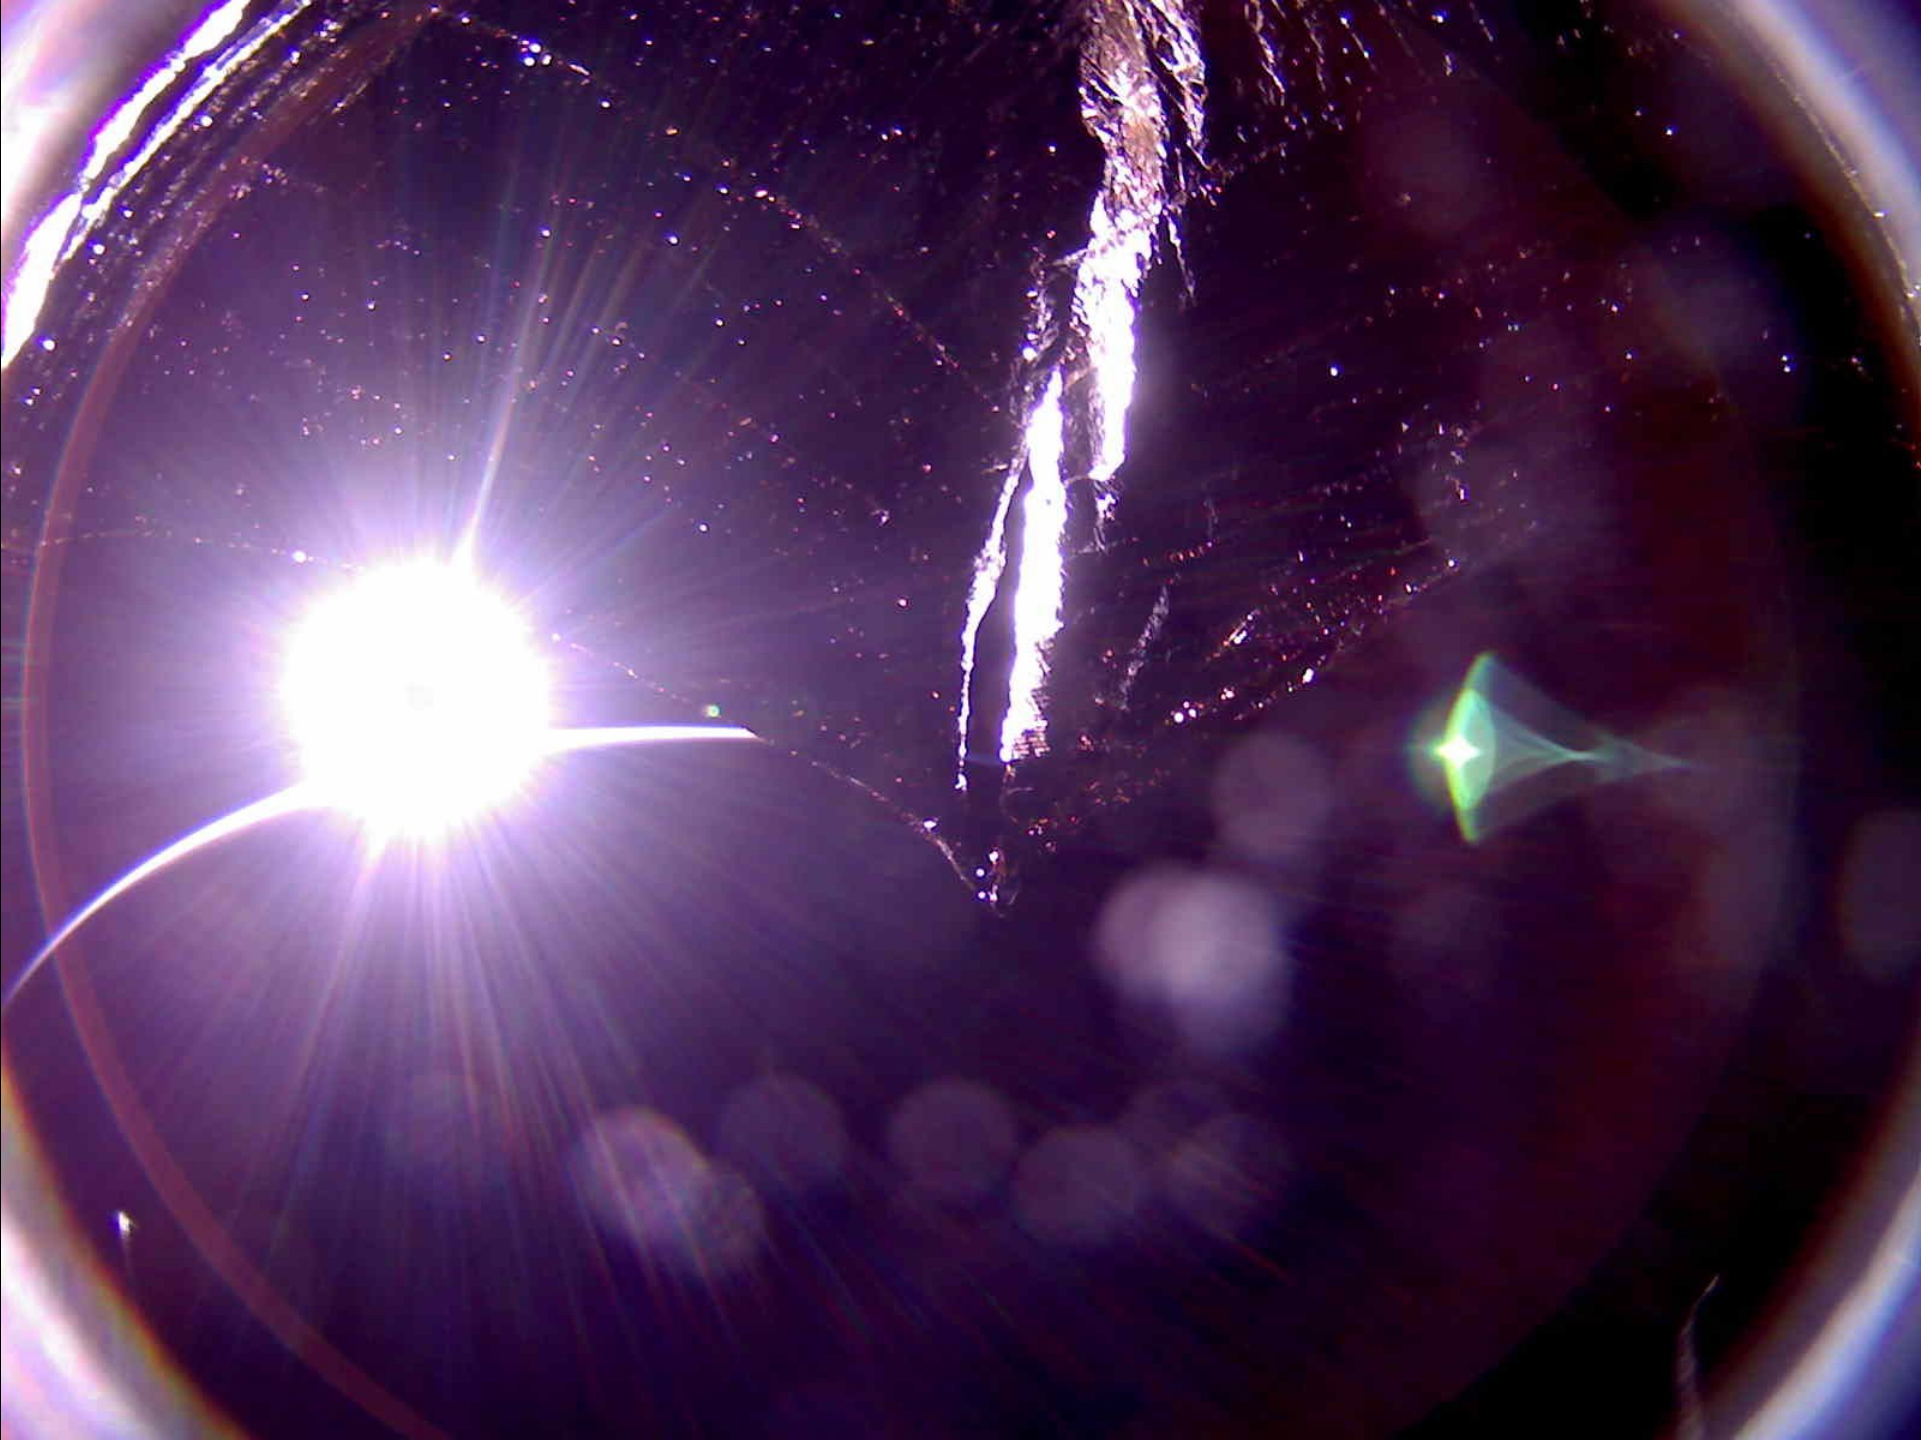
LS2
Camera 1
01/06/21
Spots
