# LIDT for femtosecond laser optical components

Viviana Vladutescu<sup>1</sup>, Mikhail Polyanskiy<sup>2</sup>, Dismas Choge<sup>2</sup>, Tahsinur Rahman<sup>1</sup>, Tianyi Zhao<sup>1</sup>, Marcus Babzien<sup>2</sup>, William Li<sup>2</sup>, Antonio Verderesa<sup>2</sup>, Igor Pogorelski<sup>2</sup>

<sup>1</sup>New York City College of Technology of the City University of New York, <sup>2</sup>Brookhaven National Laboratory, Department of Energy

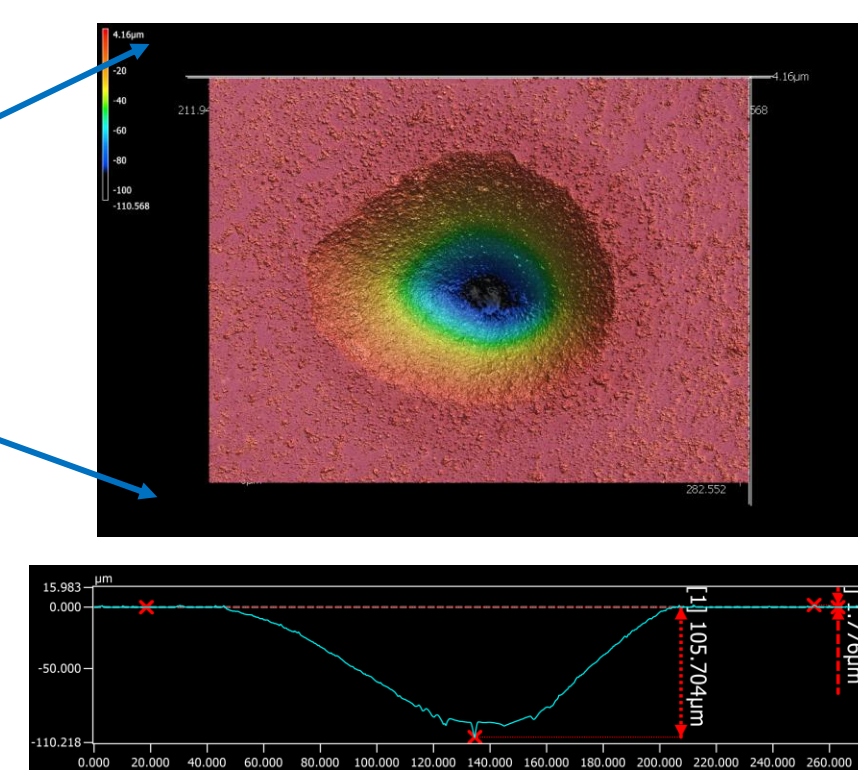
### BBO (Beta Barium Borate)

Nonlinear crystal used in Optical Parametric Amplification (OPA). Material defects lead to nonlinear damage effects.

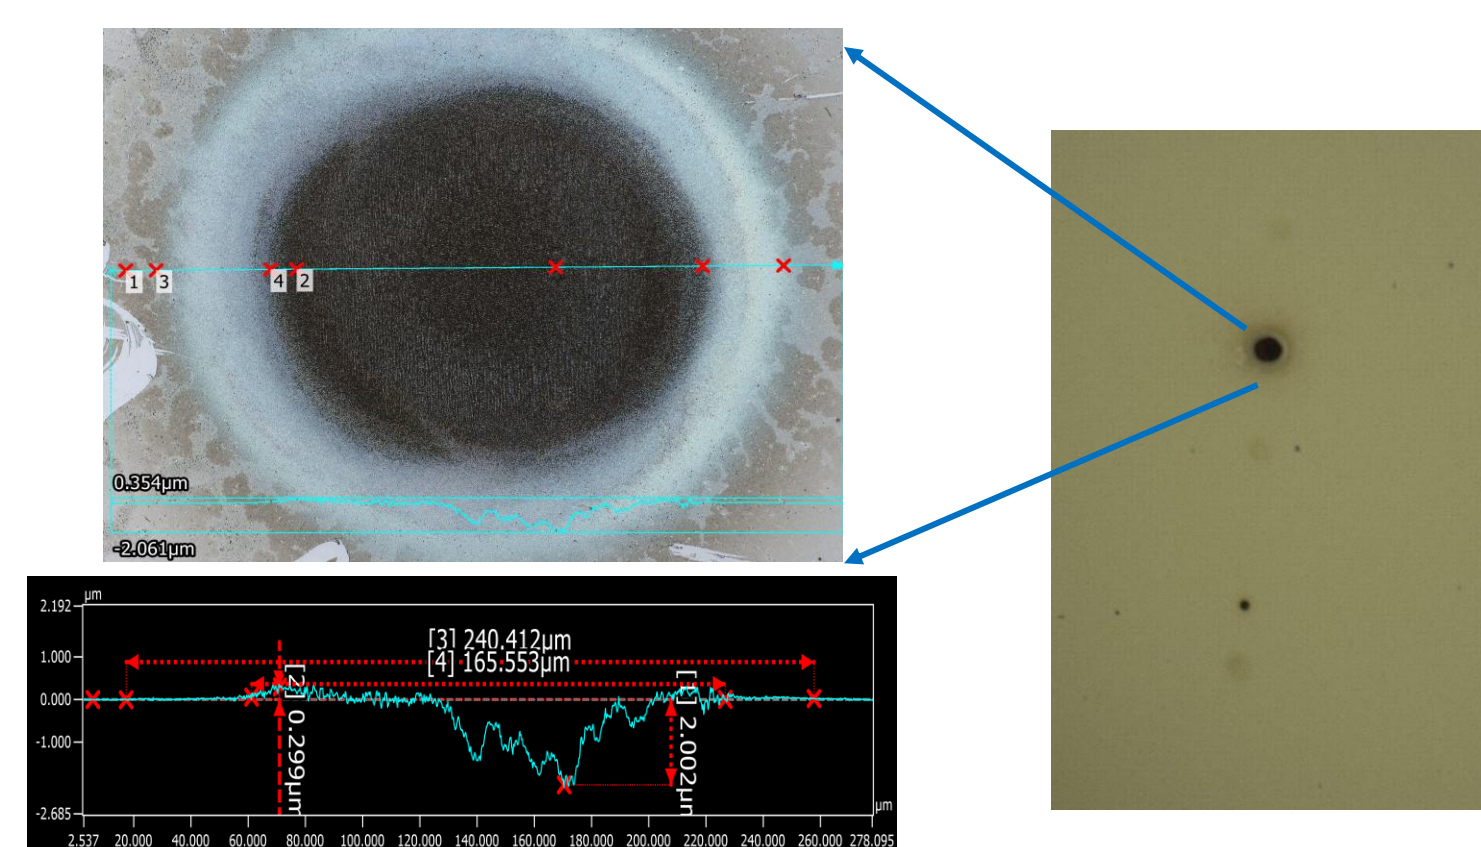
### ZnSe (Zinc Selenide)

ZnSe has a transmission window in 0.5 to 22  $\mu\text{m}$ , and a refractive index of 2.52 at 800 nm, being used as a plasma mirror for CO<sub>2</sub> laser control systems. It is a relatively soft material which displays rapid damage. The periodic surface structure is easily visible at high fluences.
