***PVEDi***

***A GLIMPSE OF THE  
WORK WE HERE AT  
PVEDI DO IN NYC***

## PVEDI'S PROFESSIONAL SERVICES IN NEW YORK CITY

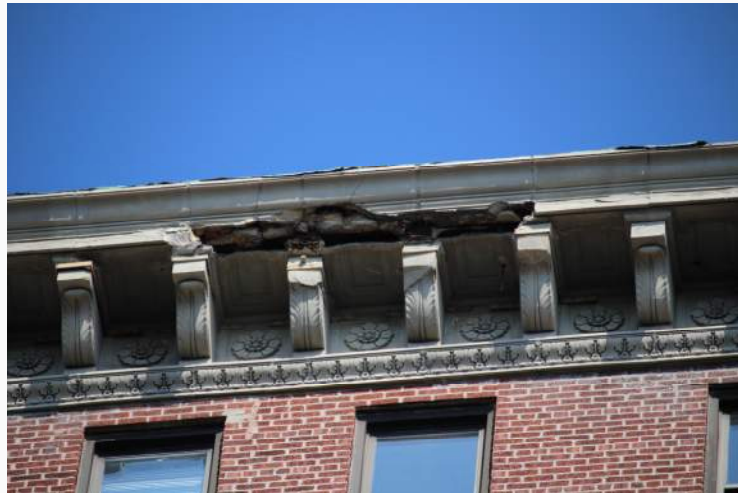
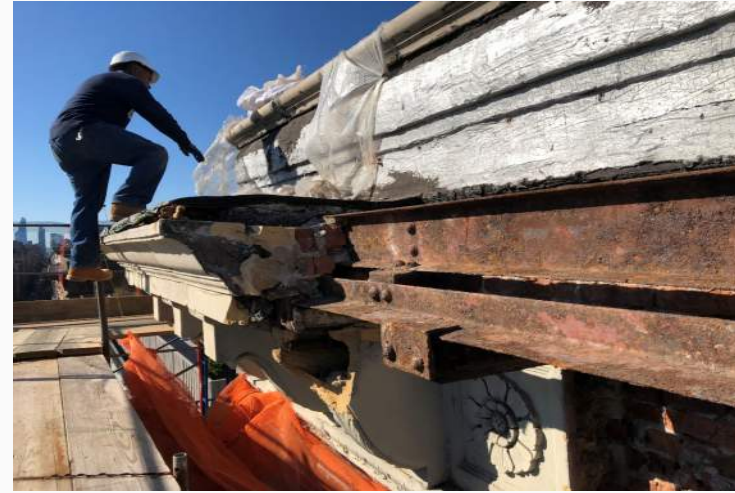
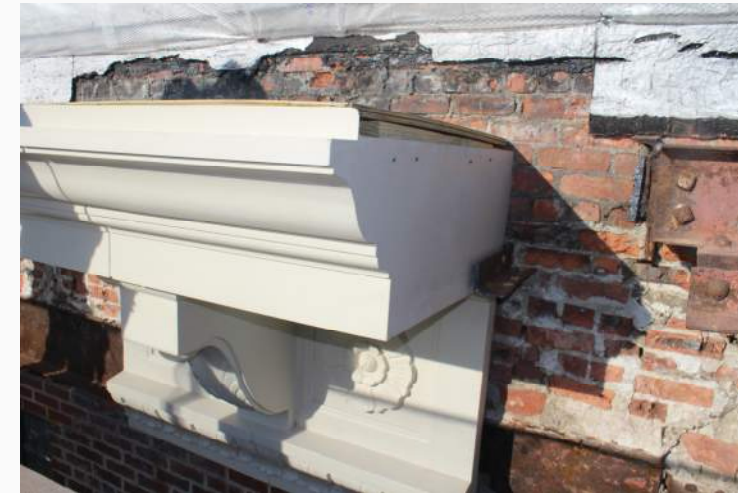
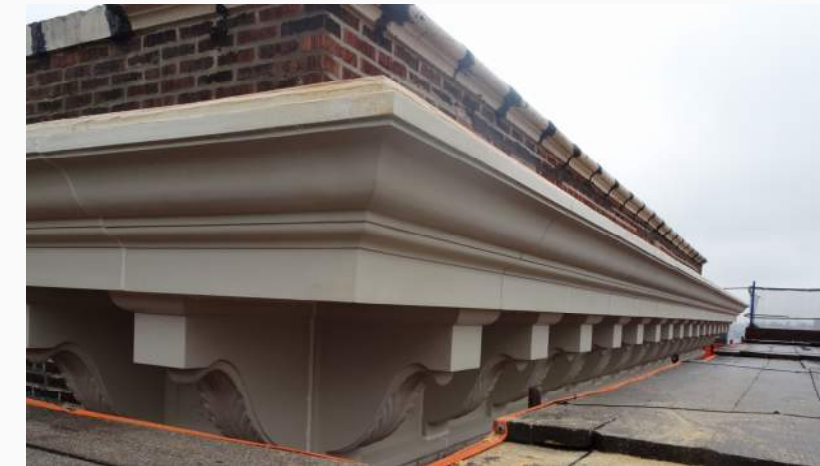
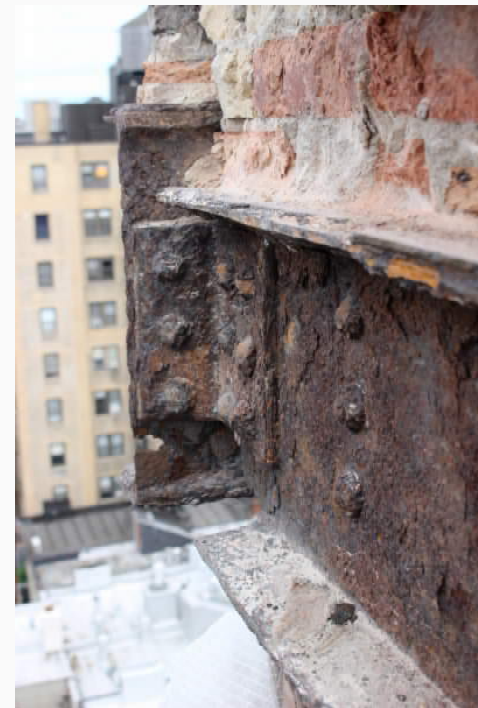
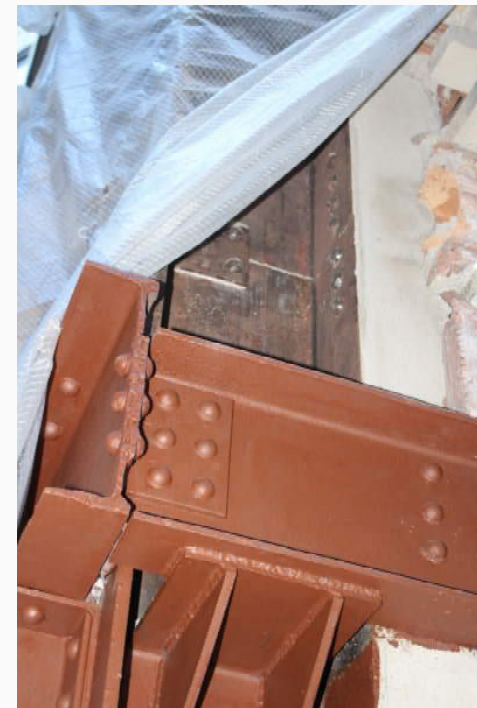
## THE CORNICE

The main forms of deterioration affecting the cornice are cracks, spalls, rusting steel framing, and missing elements. After hands-on assessment and probe observation, PVE believes that some of the elements that appear unaffected by these deteriorations may be deteriorated internally and in risk of detaching from the steel frame.

The causes of these deteriorations are likely from regular wear over the decades and have been accelerated by water intrusion.

Overall, the cornice is made up of approximately 387 terra-cotta elements. The images to the right provide a guide to the components and how they come together. The terminology noted here for the different elements will be used throughout the document.

55% of the elements are explicitly deteriorated in the form of cracking or spalling. (31% cracking and 24% spalling).

61% of the corbels have been braced with steel brackets that tie into the frieze panels. PVE believes this repair adds marginal support and may become a potentially hazardous condition of its own. The screw anchors were only embedded into the terra-cotta frieze panel, not into a structural member. Other patching repair methods are discussed further.

The elements that are cracked could potentially be repaired without replacing the whole piece. If the cracked area is sounded and found to be structurally sufficient with an adequate back-up, an injected epoxy repair with embedded fasteners could seal the gap. PVE predicts that many of the elements will not be sturdy enough for this kind of repair based on the size of the cracks.

Spalling stone and terra-cotta can sometimes be repaired by applying a patch in the affected area. Similar to the crack repair, the elements and back-up must be sturdy enough to support the patch. PVE does not recommend attempting to repair the spalling elements in this case, as much of the cornice, the back-up material, and support frame have observed deficiencies that would not provide sufficient evidence for a significant cementitious patch repair. Additionally, many of the spalled areas exceed the size recommended by representatives of reputable industry standard products.

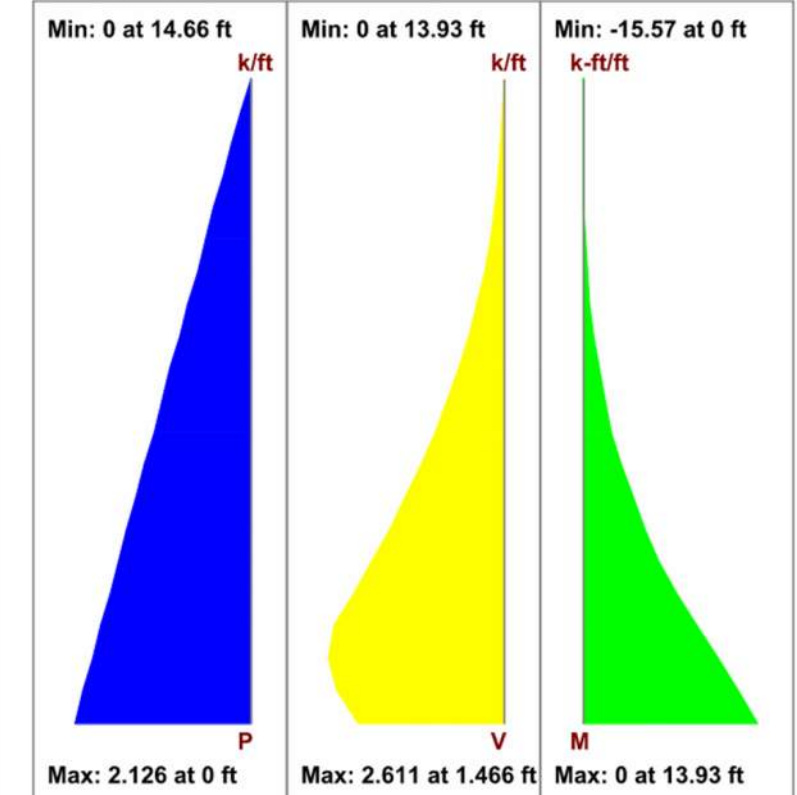
### LC 1 DIAGRAMS

## Wall Design
