# Test of a Full-Scale Quadrant for the 1,653m<sup>2</sup> Solar Cruiser Sail

Zachary McConnel <sup>a\*</sup>, Brian Sanders <sup>a</sup>, Anan Takroori <sup>a</sup>, Craig Hazelton <sup>a</sup>, Jim Pearson <sup>b</sup>, Carlos Diaz <sup>c</sup>, Ashley Benson <sup>c</sup>

<sup>a</sup> Redwire Space Systems, Longmont, Colorado, USA

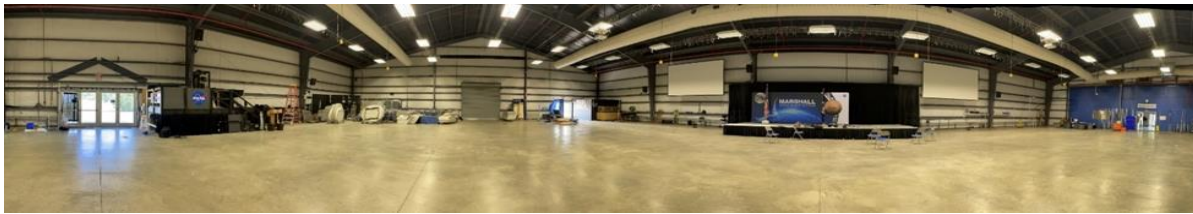
Fig. 3. Panoramic view and floor layout of test facility (MSFC B4316).

The full-scale quadrant deployment test took place in Building 4316 at NASA's Marshall Space Flight Center (MSFC, Fig. 3). The open layout of B4316 provided sufficient floor space for the full quadrant test as shown in the floor layout sketch in Fig. 3.

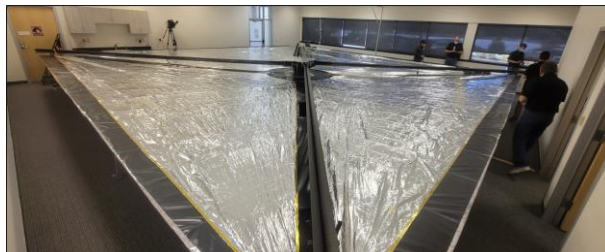
Fig. 4. Quarter-scale sail deployment test.

Three quarter-scale sail deployment tests were conducted at Redwire's facilities in Longmont, Colorado on a complete sail with four quarter-length booms and four quarter-scale sail quadrants (Fig. 4) to facilitate development of the ground support equipment. Once the ground support equipment was finalized and installed at MSFC B4316 a full-length boom deployment test was conducted without the sail, and an additional quarter-scale mylar sail quadrant deployment test was done to ensure the alterations to ground support equipment were effective in reducing deployment risks.

The quarter scale sail deployments were done with mylar sails roughly eight meters on each side (being referred to quarter scale by deployment length). These tests provided critical understanding of the deployment dynamics of the sail in a 1g environment. The mylar material is stronger than the CP-1/VDA material being used on the full-scale deployment but showed the unfolding movements that could be expected. Any snagging risks observed in these preliminary deployments, due to test conditions, were recorded and mitigated with additional MGSE for the last quarter scale deployment and the full sail deployment. These test conditions are due to deploying in a 1g and with only a single quadrant.

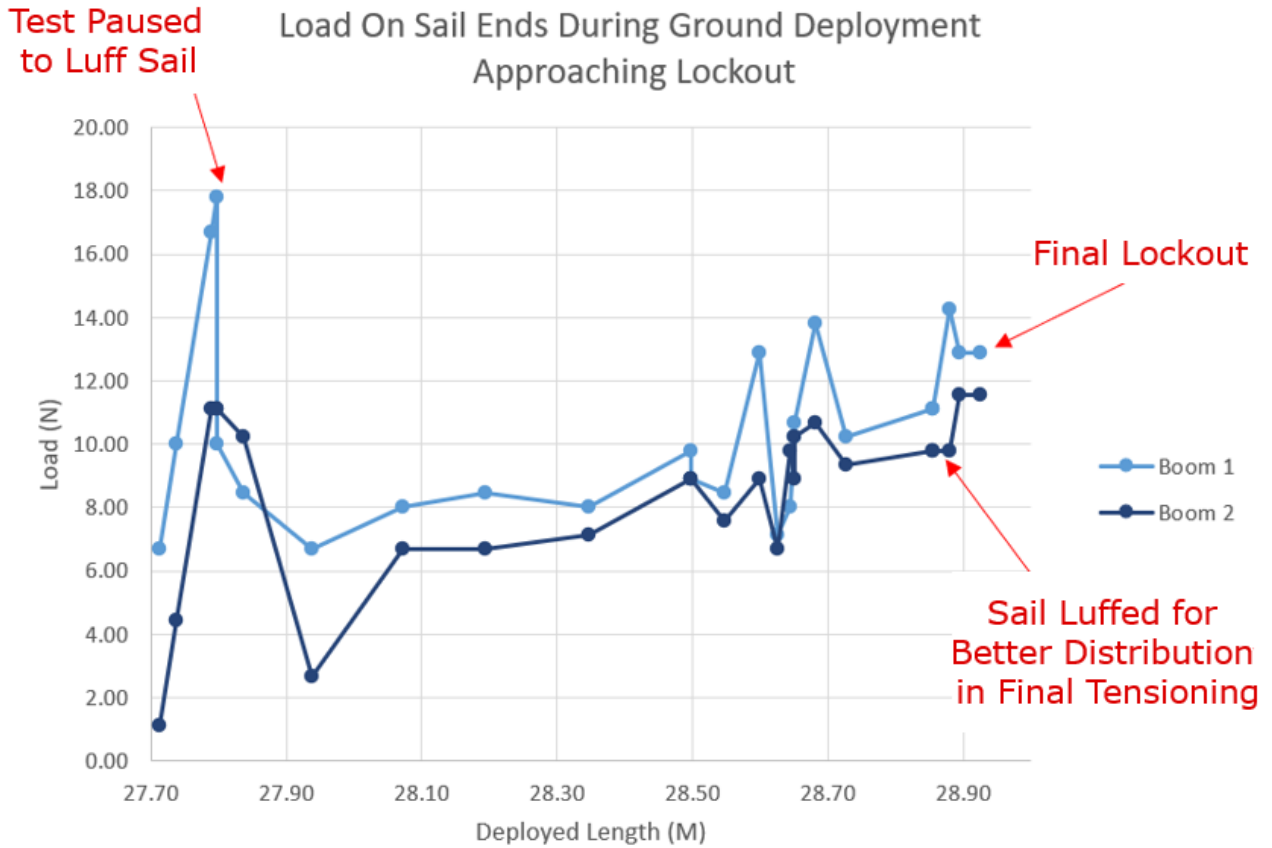
Fig. 6. Loads on sail ends during the final few meters of deployment, with some key events labelled in red.

The tension at each boom was near zero for the first quarter of deployment but the tension loads increased as more of the sail's mass left the spool and was resting on the ground. The tension spiked at 27.7m of deployment, and the luffing method was used to prevent damage to the sail. Once the tension was reduced and the sail settled back to the ground, the deployment continued. The two corners experienced different tensions throughout, but both steadily increased throughout the test. The distribution of the folding pattern on the deployment surface likely explains why the two booms experienced different loads.
