LightSail 2 Image-Based Engineering Assessment

LightSail 2 Mission Operations Team

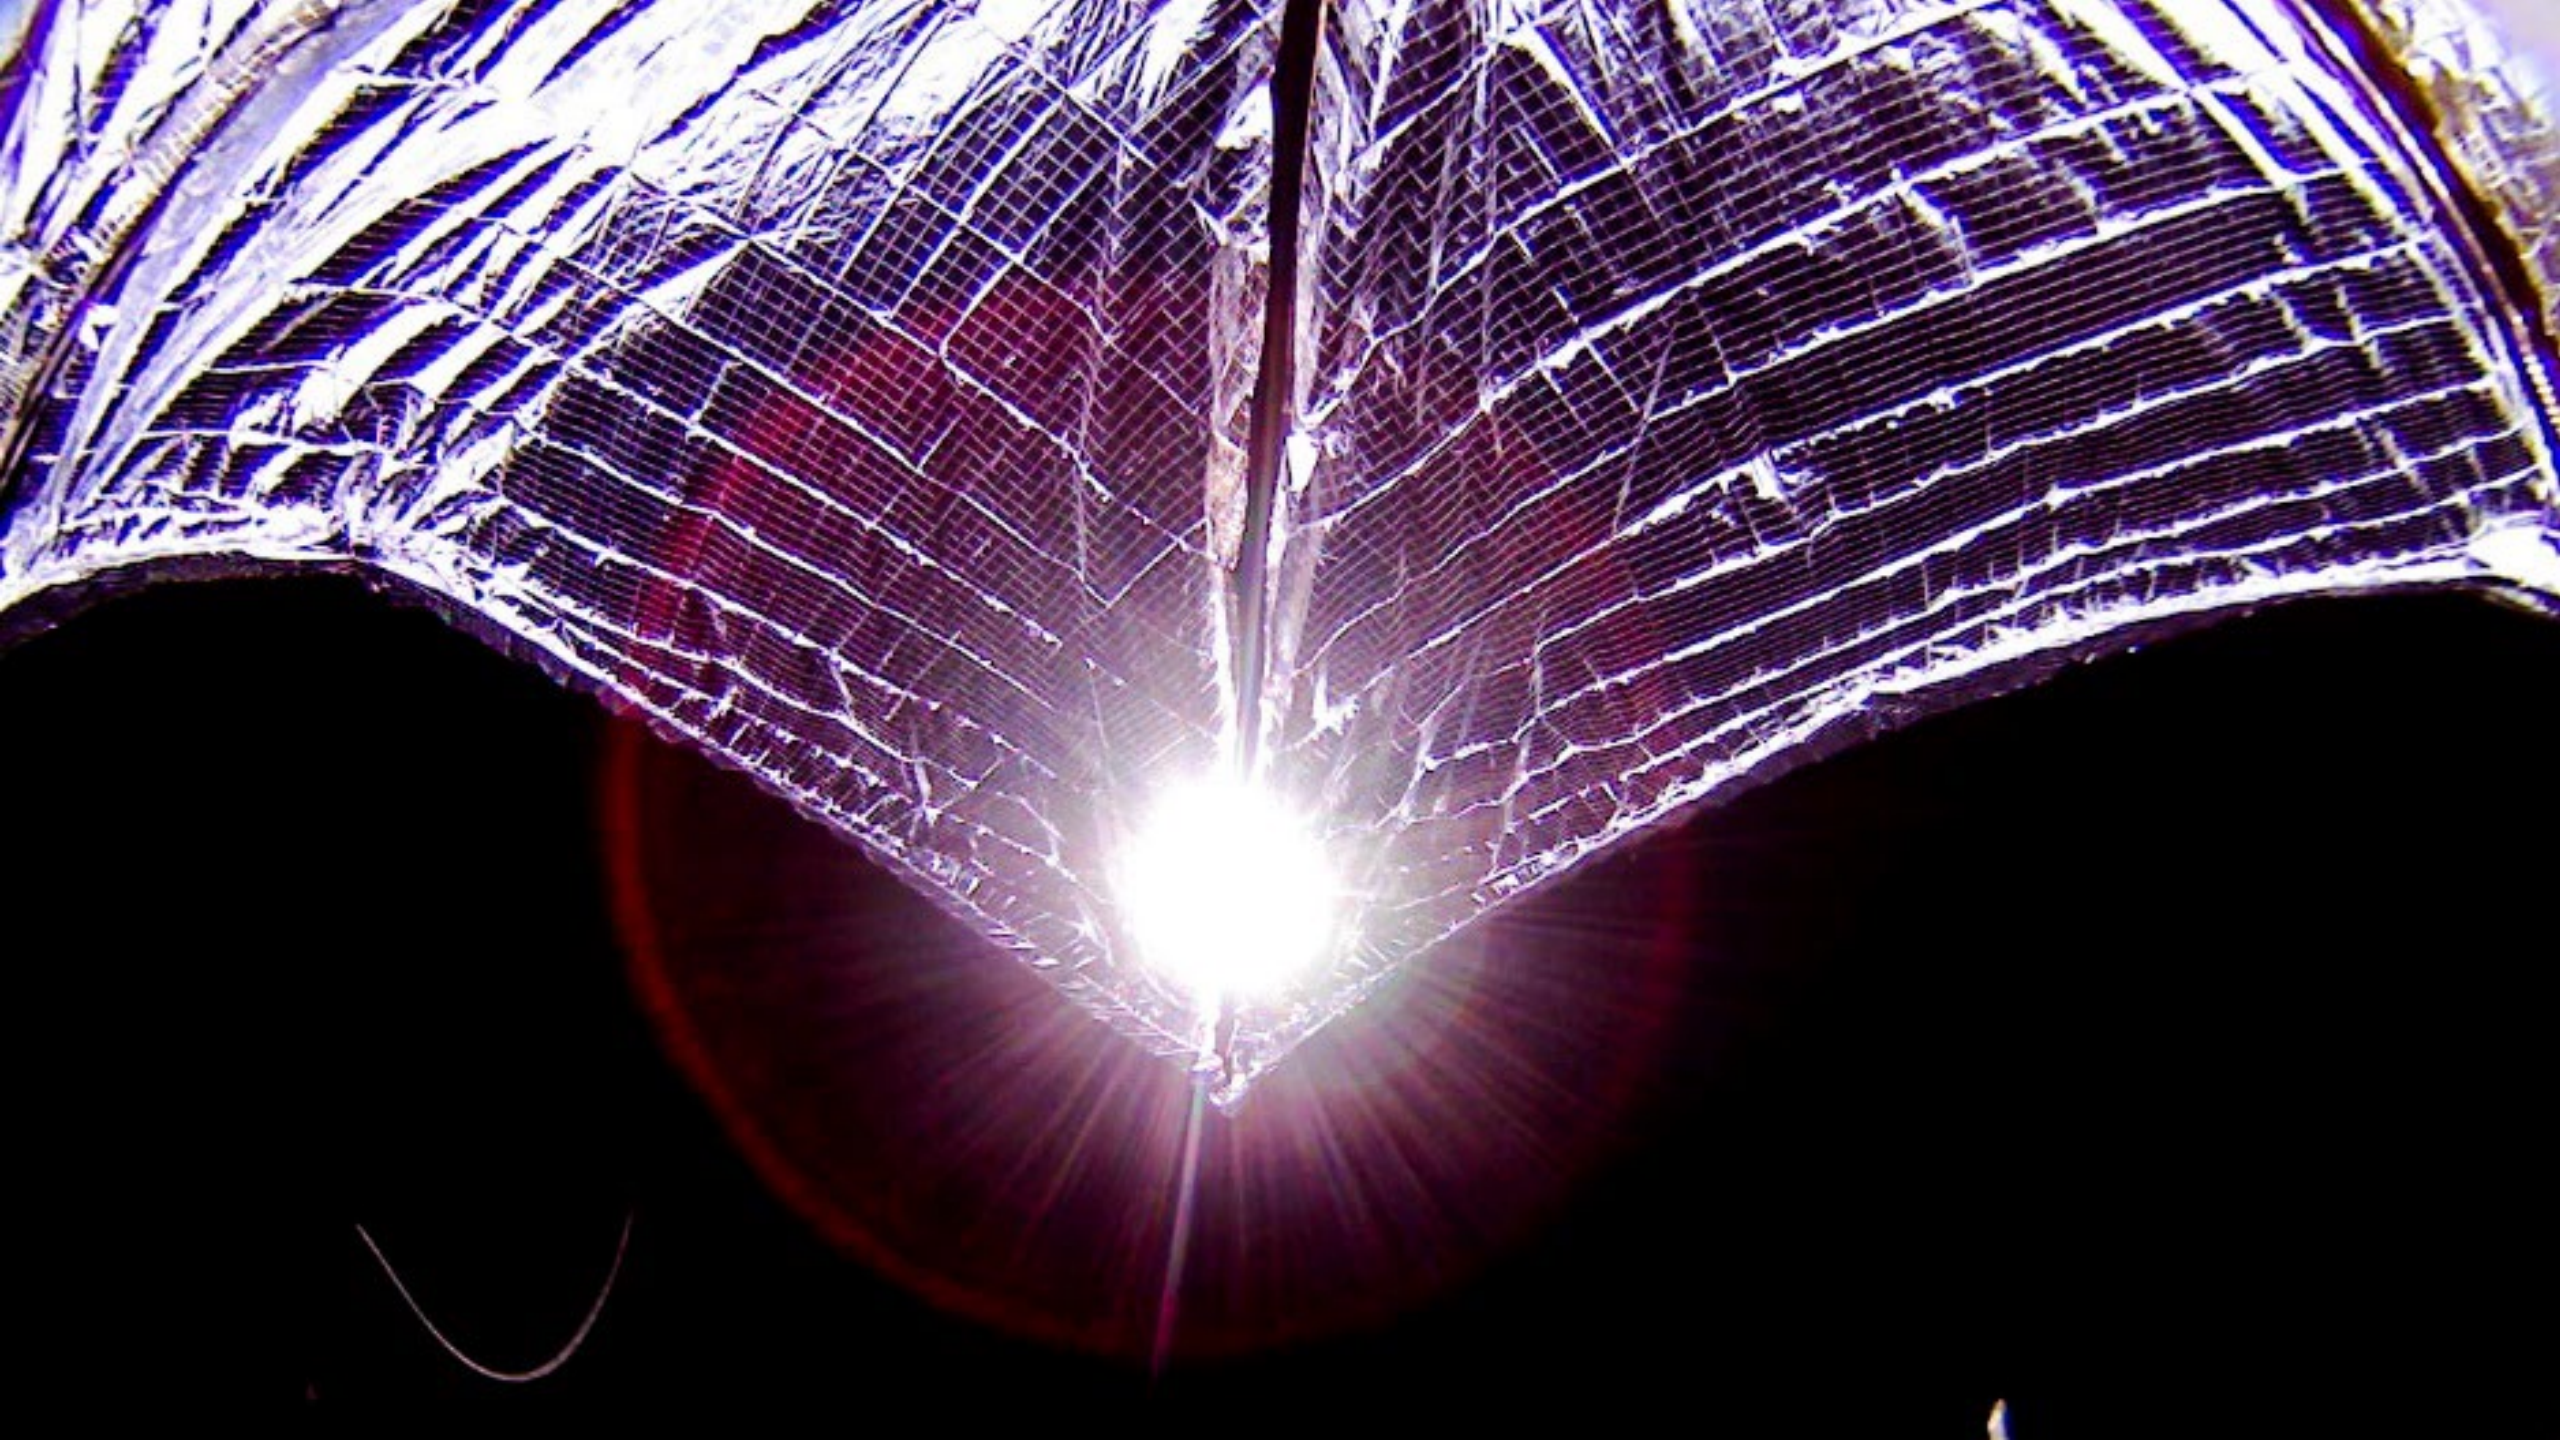
Anomalies detected through imaging included the incomplete deployment of a solar panel, which was then compensated for...

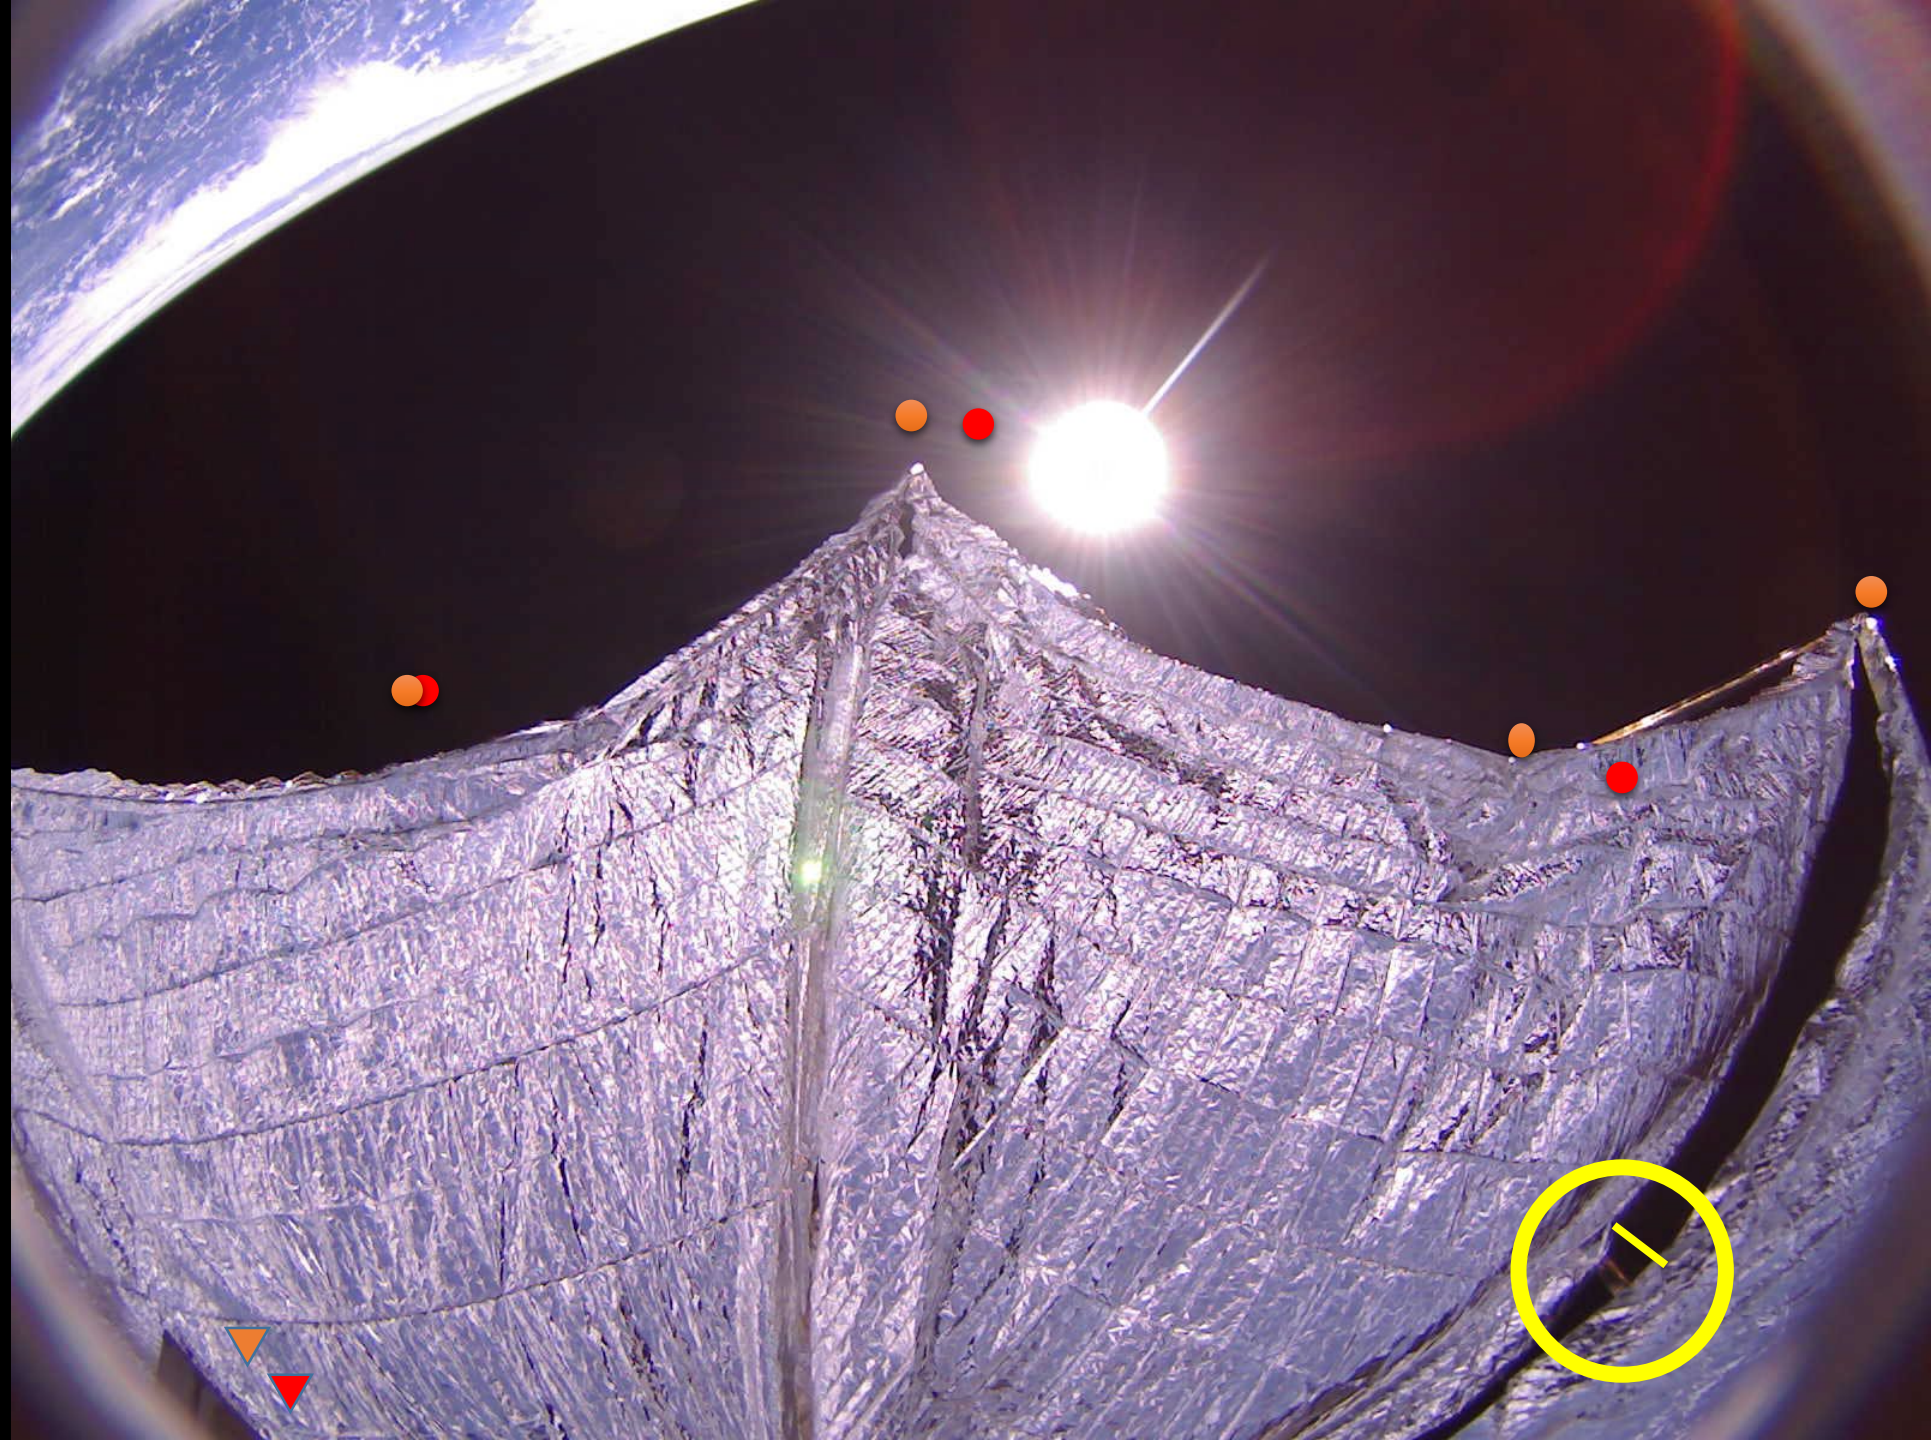
- In the previous image (9/2 D+41) we see the now very obvious linear feature parallel to the sail edge connecting to the boom tip. This is the last image in which it appears.

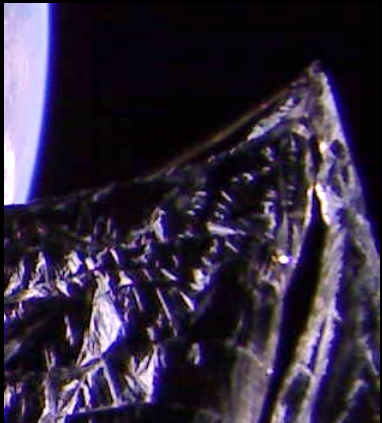
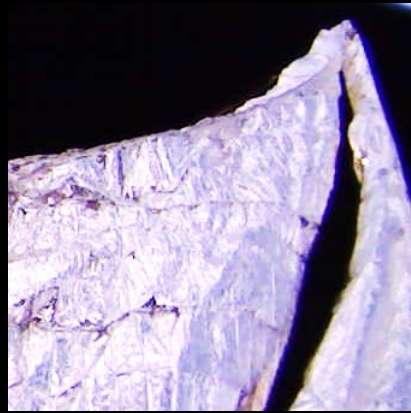
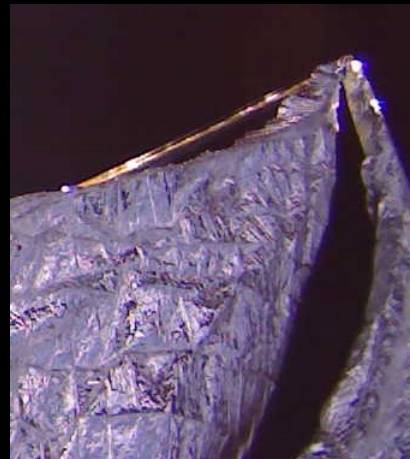
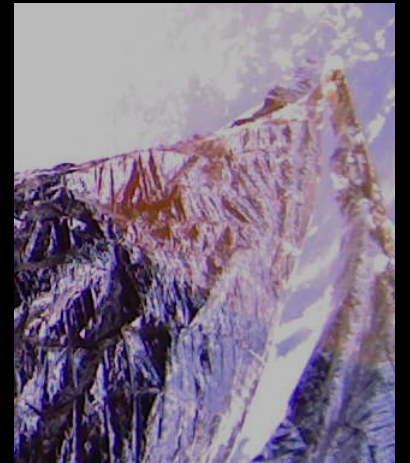
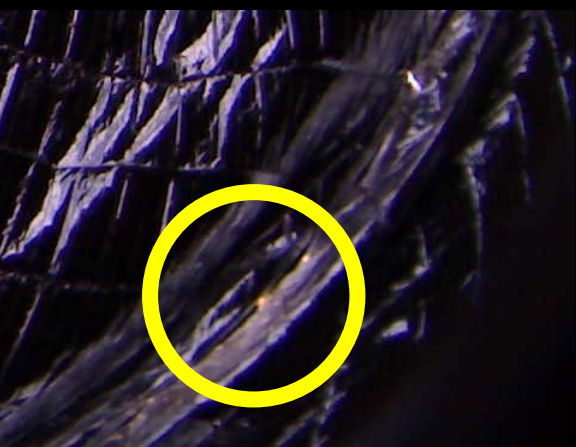
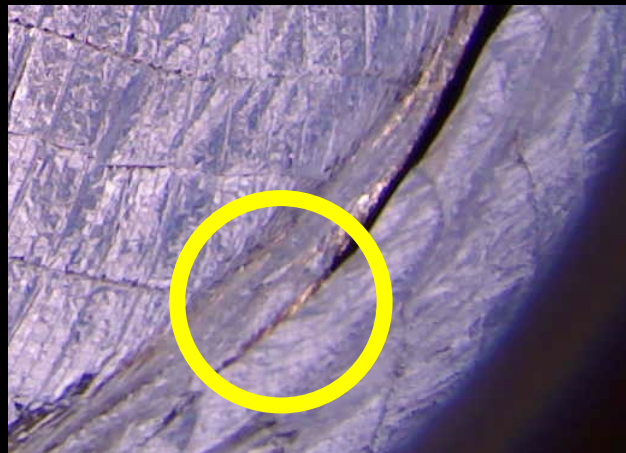
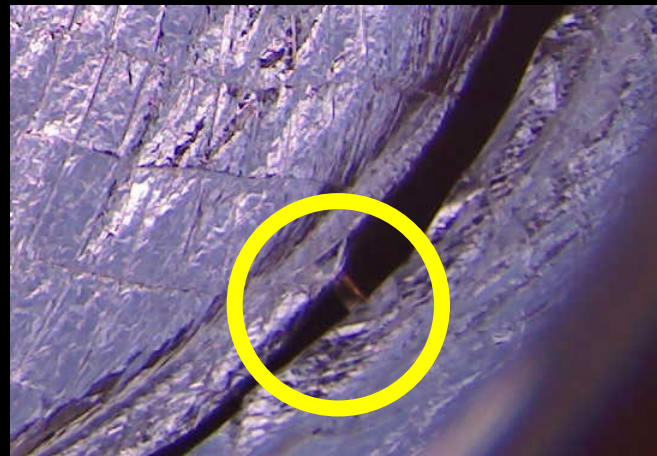
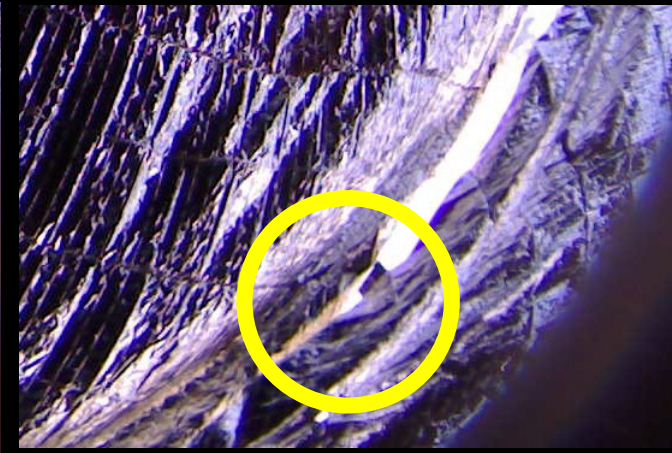
The “buckle” throughout the mission: interpretation – boom is bent not split?

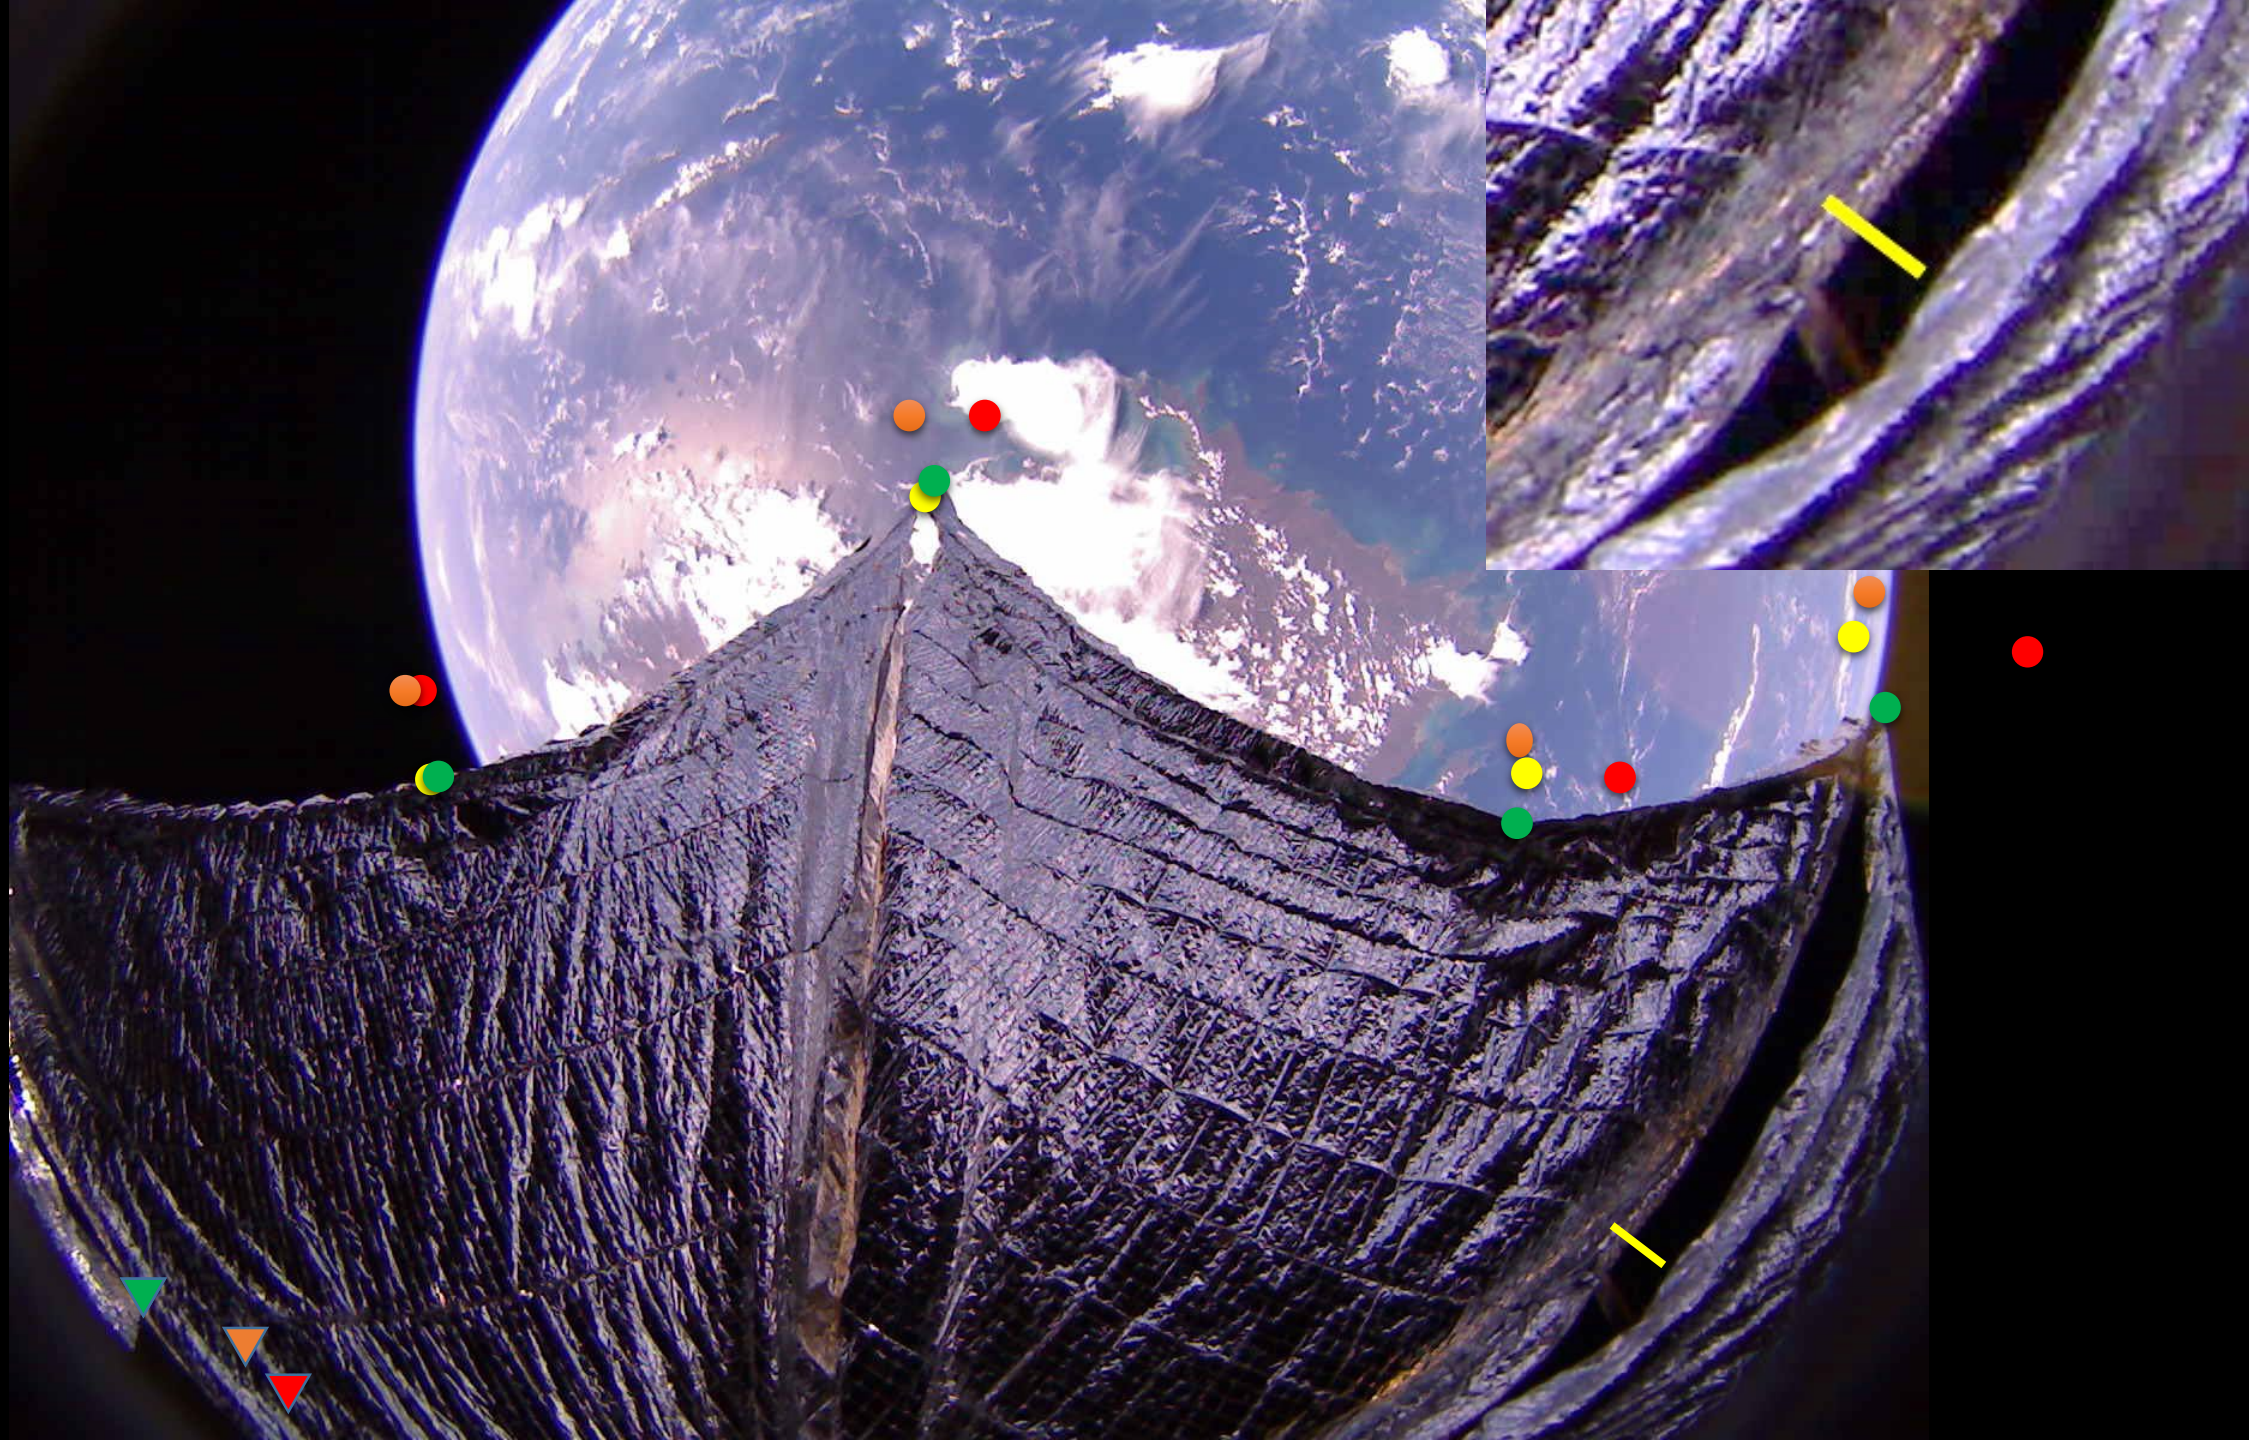
- Visible from Camera 2, one of the 4 spacecraft booms (-Y) buckled, becoming worse over the first 125 days of the mission then stabilizing
- Over time, the angle of the plane of the sail shifted systematically as seen in both cameras.
- Small variations in boom position were also noted on timescales of minutes, likely due to thermal expansion and contraction of the Elgiloy booms.

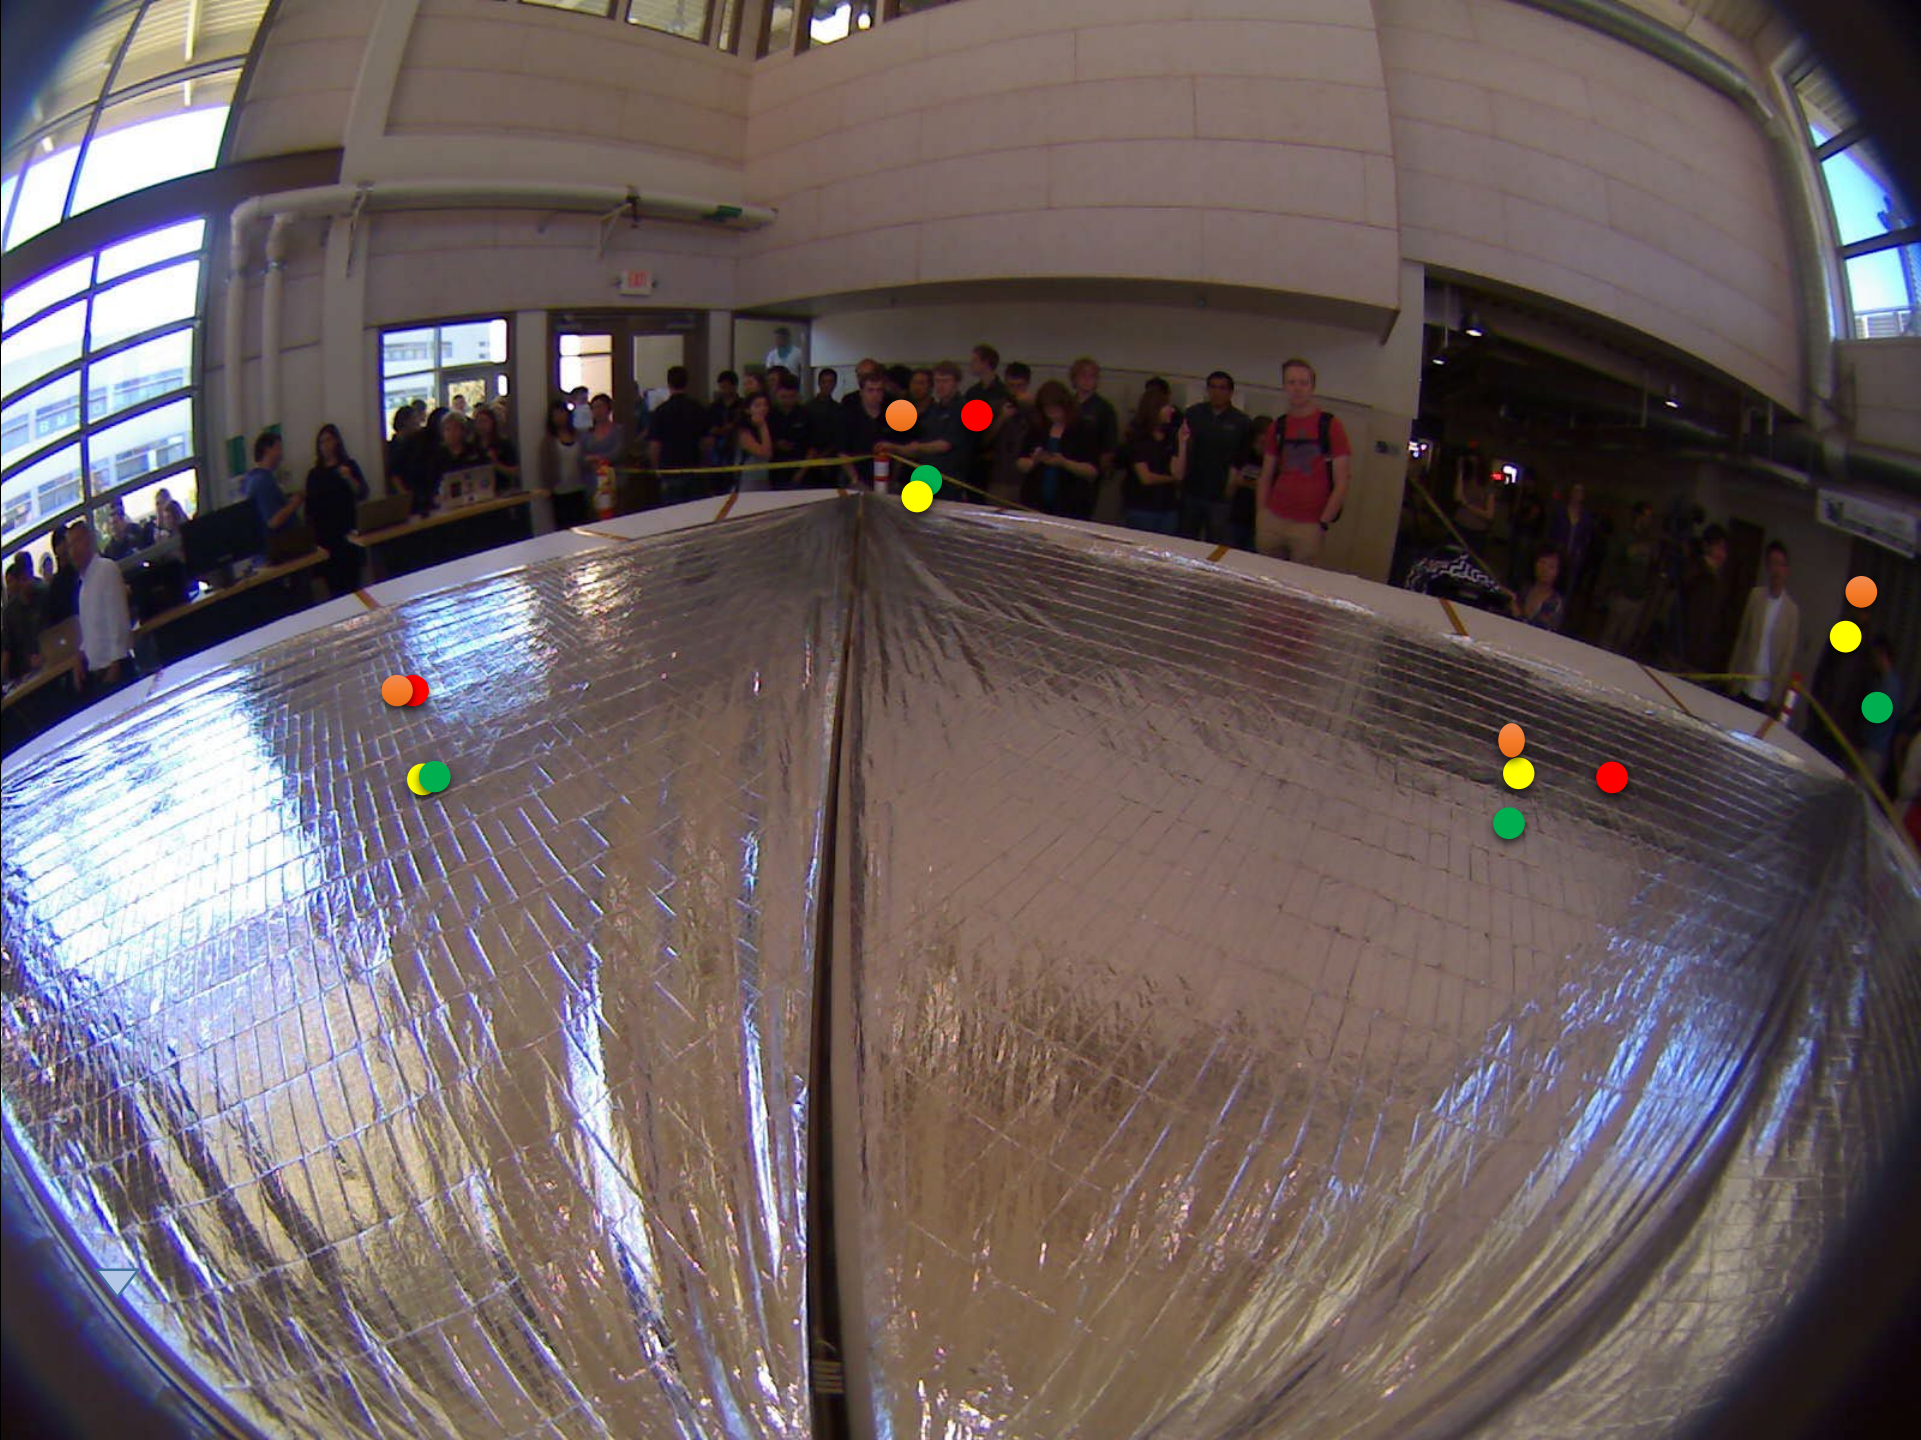
Deploy
test.
Camera
2.
On-orbit
Camera 2
dots are
shown.

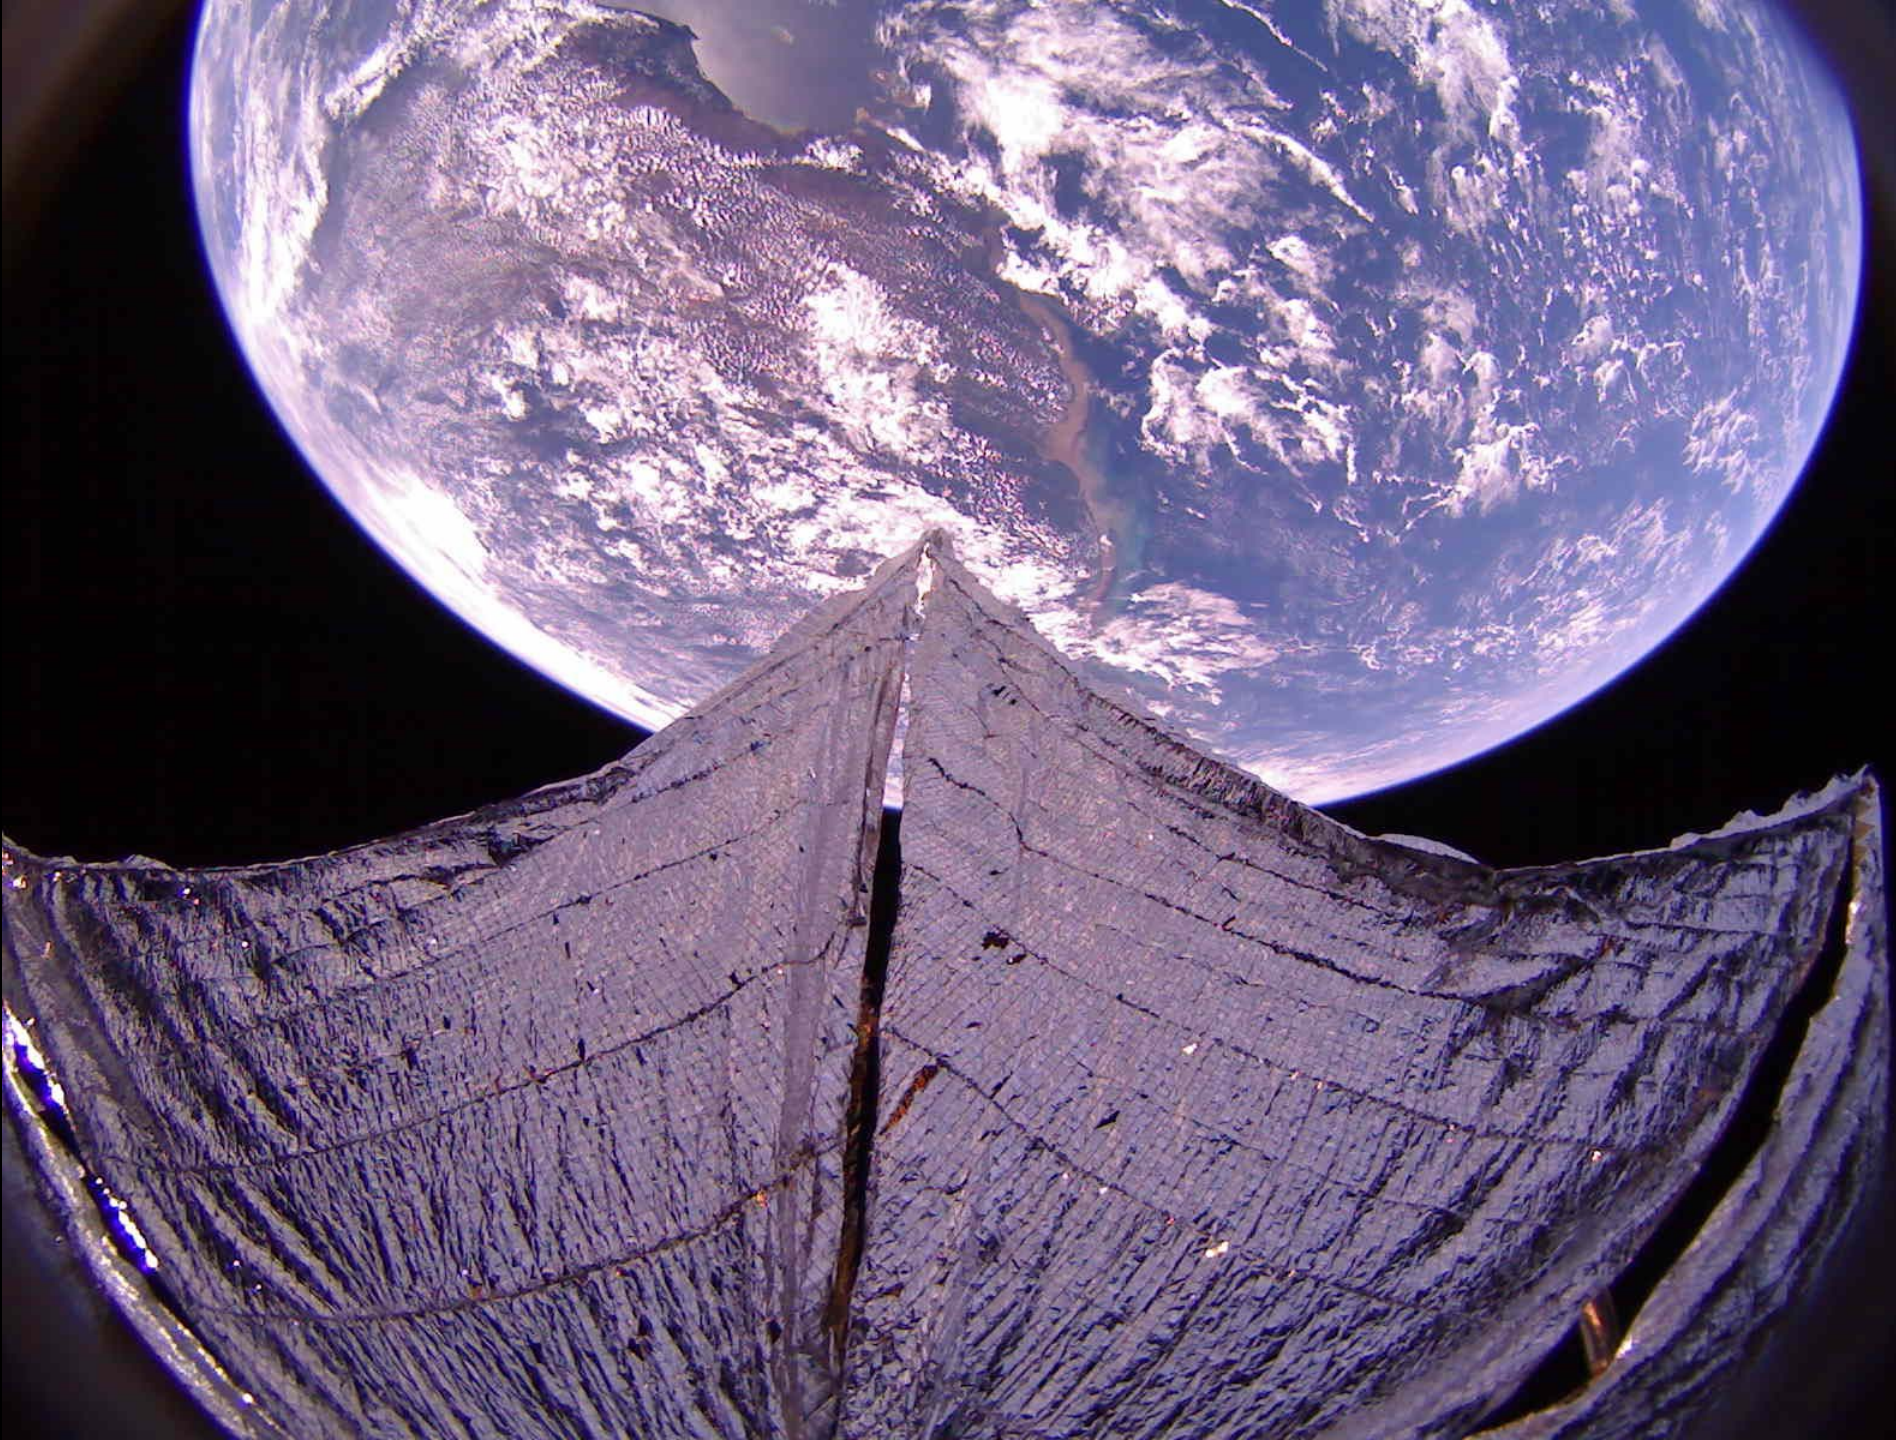
D+577
02/19/21

- Wrinkles developed within days to weeks then stabilized.
- Small areas of aluminum delamination and the development of small holes occurred over months to years.
- Sagging occurred over time but no loss of integrity predicted by some lab experiments
- Rip stop threads did seem to prevent very large holes

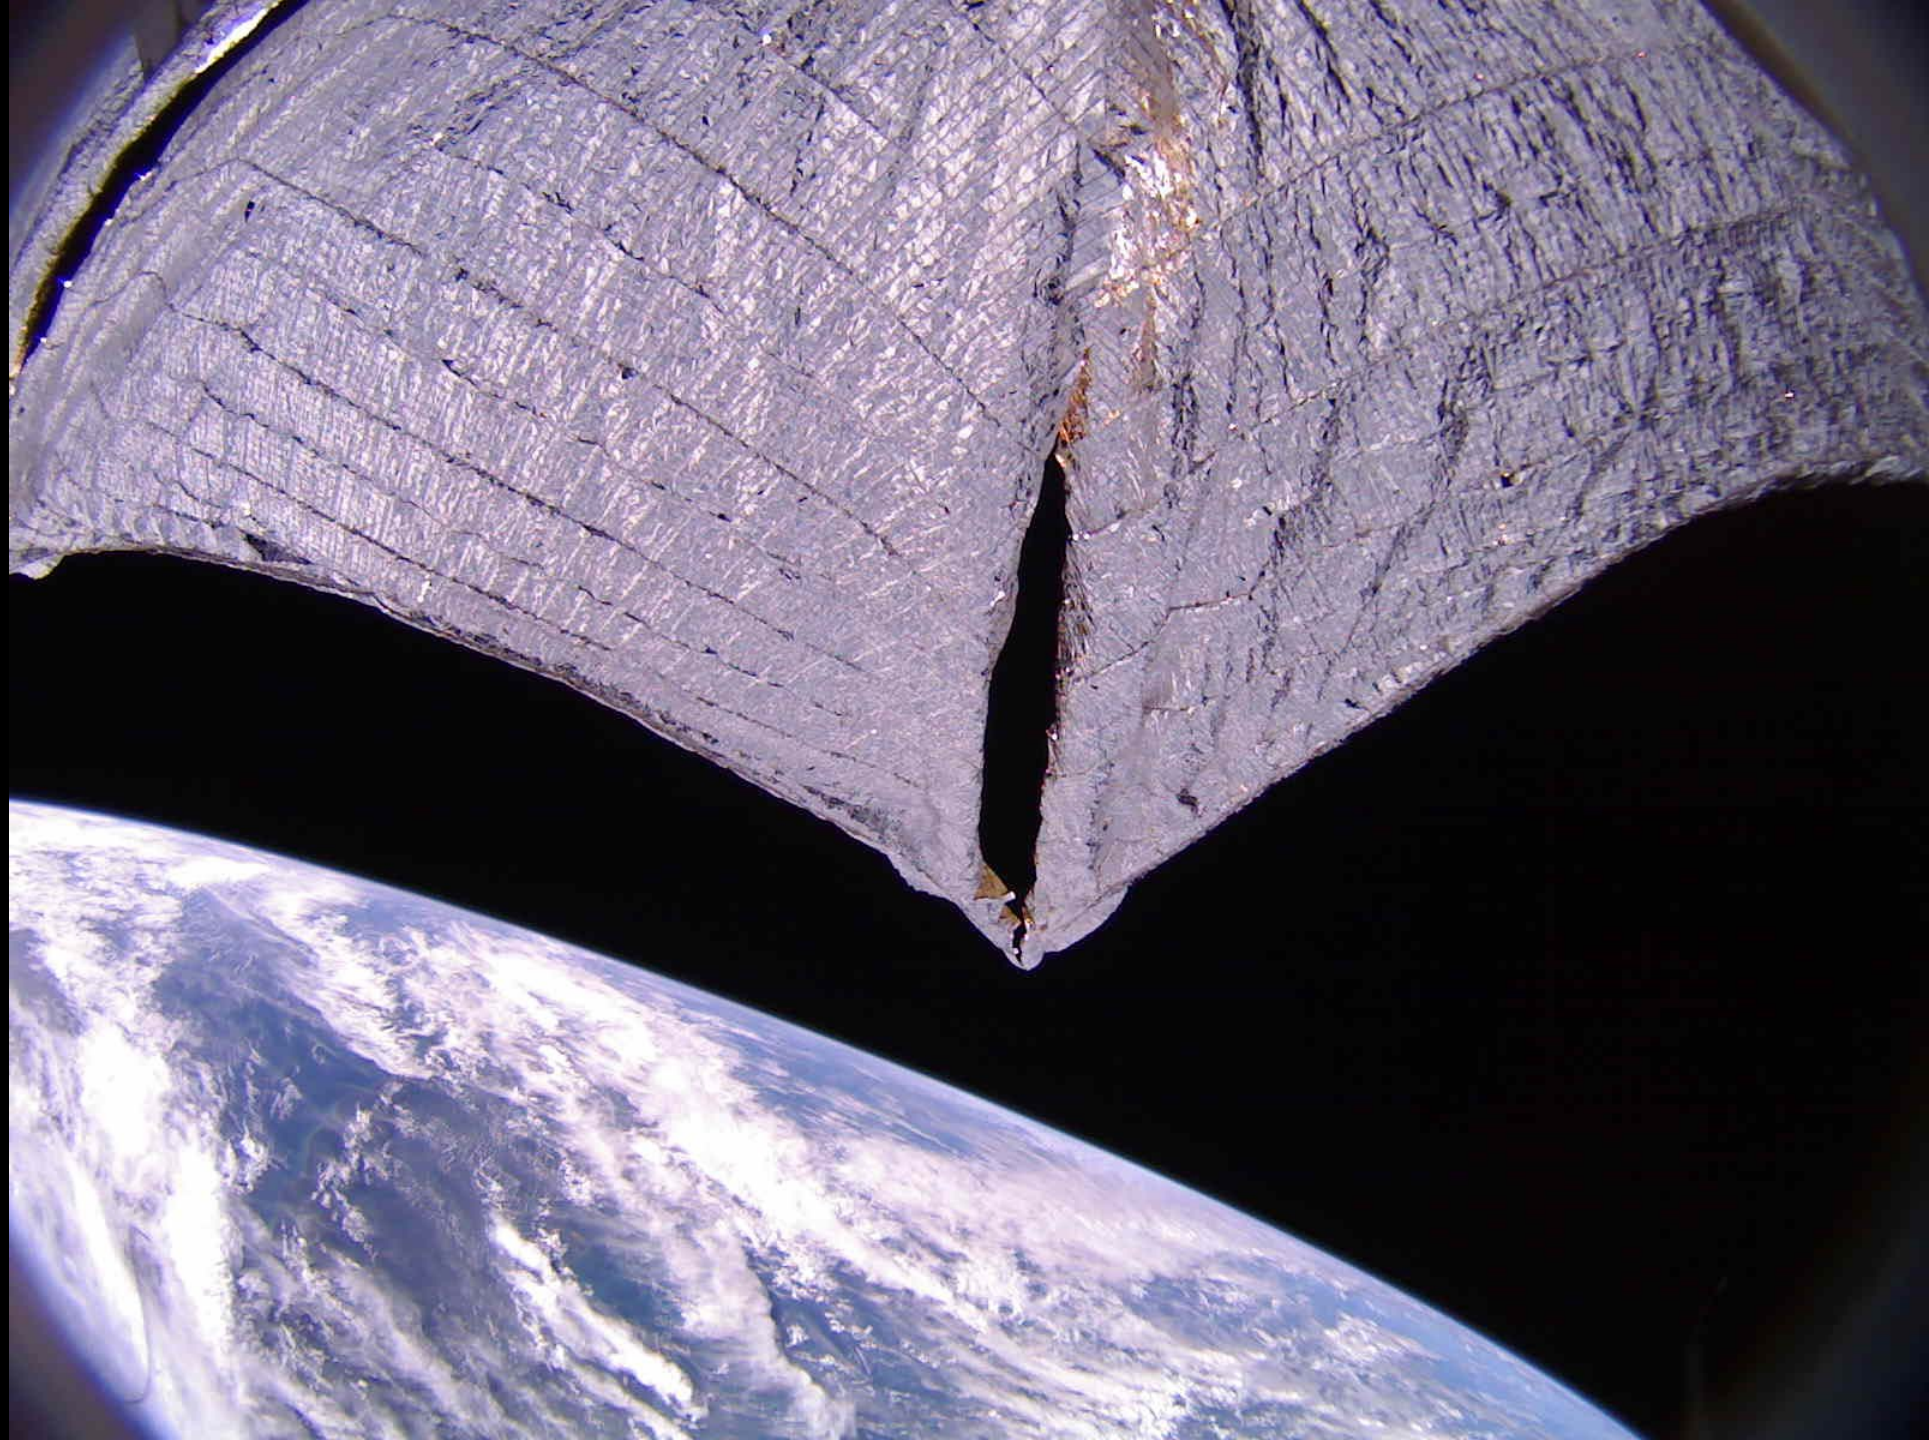
LS2
Camera 1
12/4/20

No spots
